Bulletin ServiceLink

Bulletin SL9-91

4X4 BALL JOINT INSTALATION IMPROPER INSTALLATION CAN CAUSE STEERING PROBLEMS AND PREMATURE BALL JOINT FAILURE

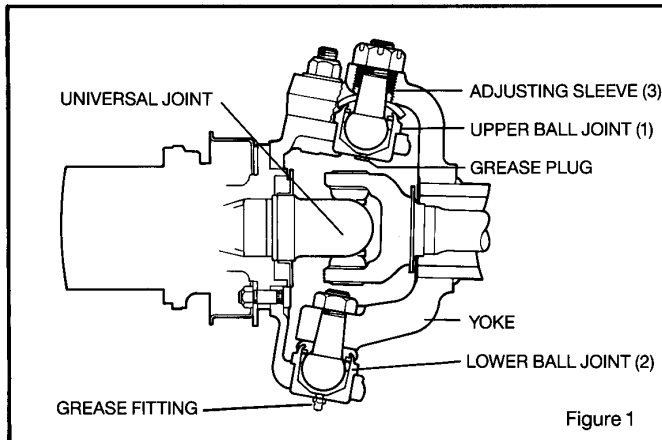
On this type axle, upper (1) and lower (2) ball joints are load carriers. To ensure that the load is properly distributed an adjustment sleeve (3) is used, in conjunction with the upper ball joint. (Fig. 1)

Improper tightening or backing off the adjustment sleeve can cause tight steering which can cause steering wander. Improper loading of ball joints can also occur, causing premature ball joint failure.

TORQUE SEQUENCE	TORQUE
1. Lower Ball Joint	70 Foot Pounds
2. Adjusting Sleeve	70 Foot Pounds
3. Upper Ball Joint	100 Foot Pounds

NOTE: Clean threads before installing new sleeve. Threads must be clean or torque accuracy will be affected.

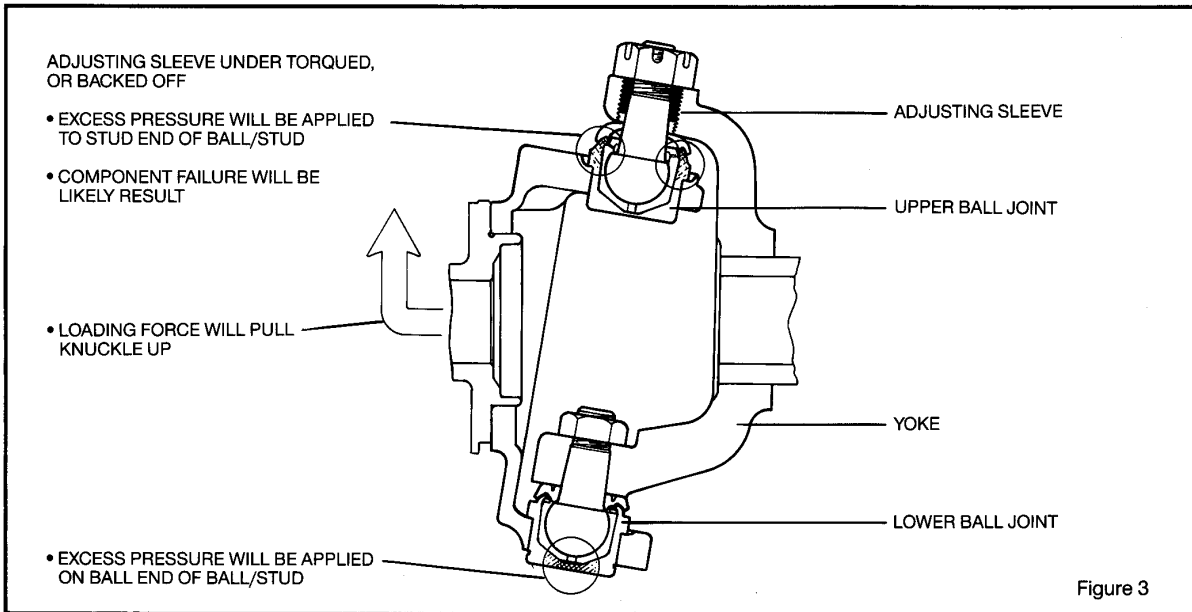
IMPROPER INSTALLATION

RESULT: HARD STEERING, COMPONENT FAILURE

The improper installation shown above or hard steering complaints can be minimized by checking spindle tightness as shown in Fig 2.
