SPICER LIFE SERIES™ FEATURES & BENEFITS

This manual encompasses inspection, lubrication, removal and installation procedures for Spicer Life Series™ 55, 70, 90, 100, 140, 170 and 250 driveshaft assemblies.

SPICER LIFE SERIES™ INSPECTION

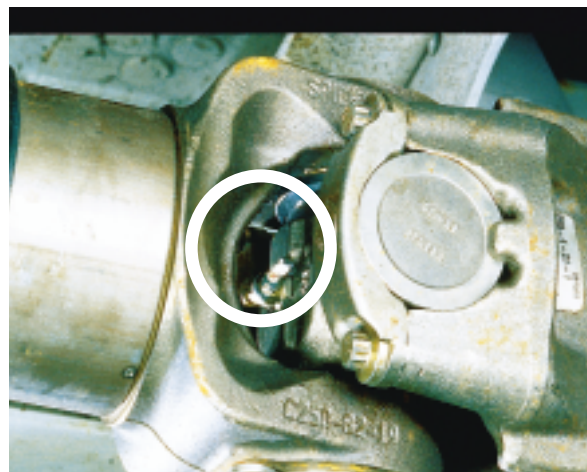
Photo 4, Reliable Style

7. Check for the presence of all grease zerk (nipple) fittings. (See photo 4, above). Grease zerk (nipple) fittings should not be missing, loose or fractured. ⚠ See warning, below.

If grease zerk (nipple) fitting is loose, tighten to required specifications. (See Table B, below.)

If grease zerk (nipple) fitting is fractured, replace grease zerk (nipple) fitting and tighten to required specifications. (See Table B, below.)

If grease zerk ([nipple](#)) fitting is missing, the entire universal joint kit needs to be replaced. Refer to the removal and installation sections of this manual for proper replacement procedures.

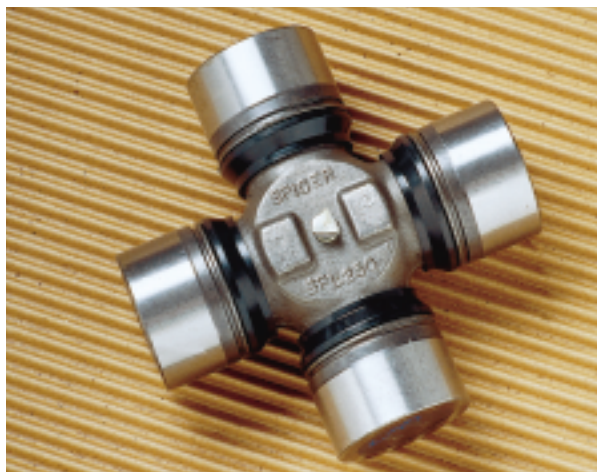
Photo 5, Permanently Lubricated Plug Style

8. Permanently lubricated plug style universal joint kits do not contain grease zerk ([nipple](#)) fittings, only a plug. (See photo 5, above.) Make sure plug is not missing, loose or fractured.

If the plug is loose, tighten to required specifications. (See Table B, step 7.) **▲** See warning, below.

If a plug is missing or fractured, the entire universal joint kit needs to be replaced. Refer to the removal and installation sections of this manual for proper replacement procedures.

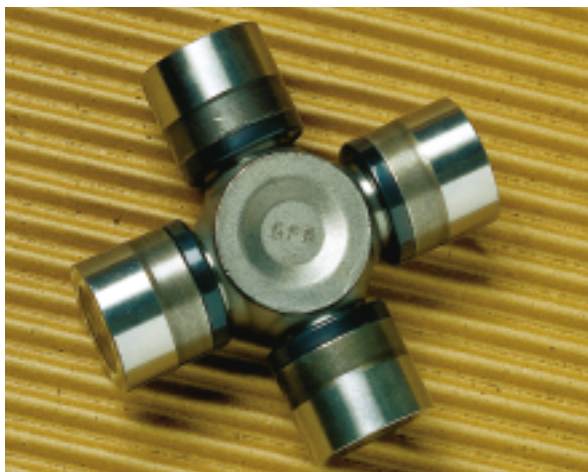
Photo 6, Permanently Lubricated Net-Form Style

9. Net-formed universal joints do not contain grease zerk ([nipple](#)) fittings or plugs and are not relubable. (See photo 6, above.)

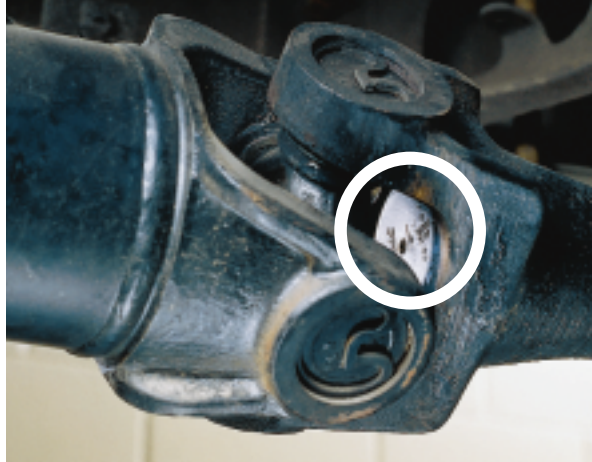
Photo 8

11. For an inboard and outboard slip yoke assembly design, check to be sure the slip yoke welch plug is not loose, missing or damaged. (See photo 8, above.) ▲ See warning, below.

If any of these situations are evident, replacement of the slip yoke and professional rebalancing of the driveshaft is necessary. Refer to the removal and installation sections of this manual for proper replacement procedures for slip members.

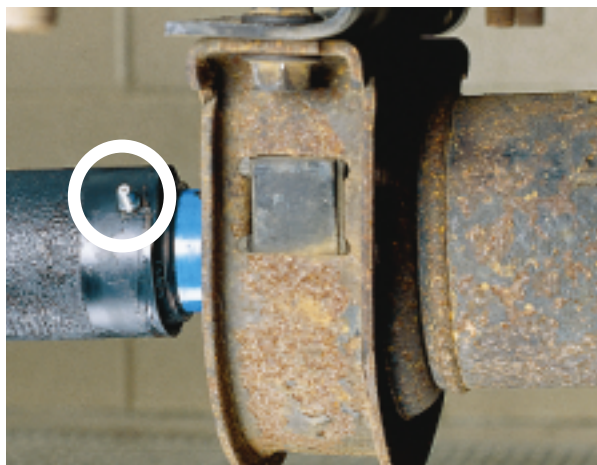
Photo 9

12. Visually inspect for the presence of the grease zerk (nipple) fitting, if applicable, on the slip yoke. (See photo 9, above.) Grease zerk (nipple) fittings should not be missing, loose or fractured. ▲ See warning, below.

If grease zerk (nipple) fitting is loose, tighten to required specifications. (See Table C, below.)

If grease zerk (nipple) fitting is missing or fractured, the slip members may need to be replaced. Be sure to follow step 10 for inspection of radial looseness in slip member assembly.

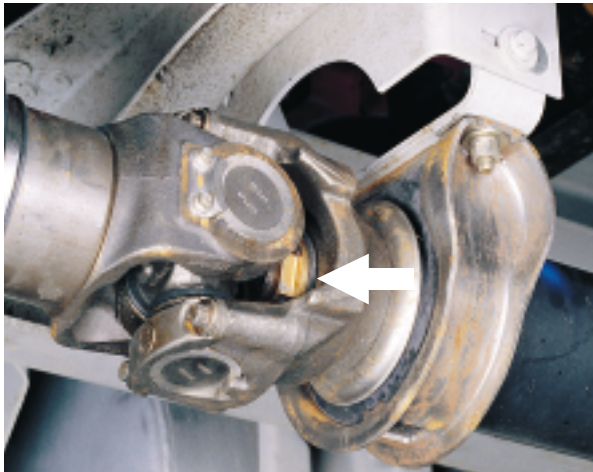
Photo 12

17. Visually inspect all center bearings, end-fitting midship nuts for any gaps between the mating surfaces. (See photo 12, above.) ▲ See warning, below.

A loose center bearing end-fitting midship nut can result in driveline failure, which can result in separation of the driveline from the vehicle. A separated driveline can result in property damage, serious personal injury or death.

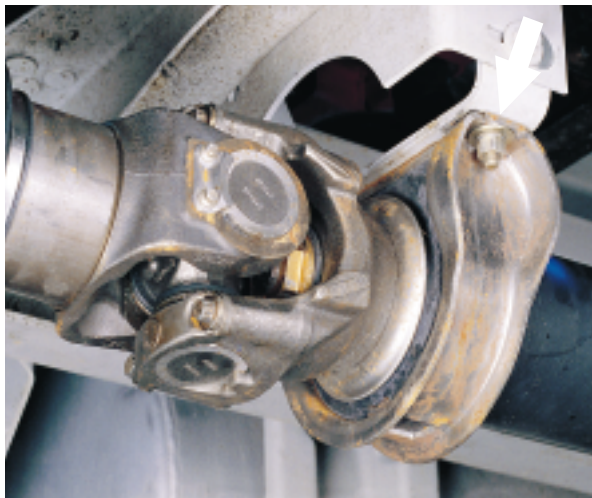
Photo 13

18. Inspect the center bearing bracket bolts for looseness. (See photo 13, below.) ▲ See warning, below.

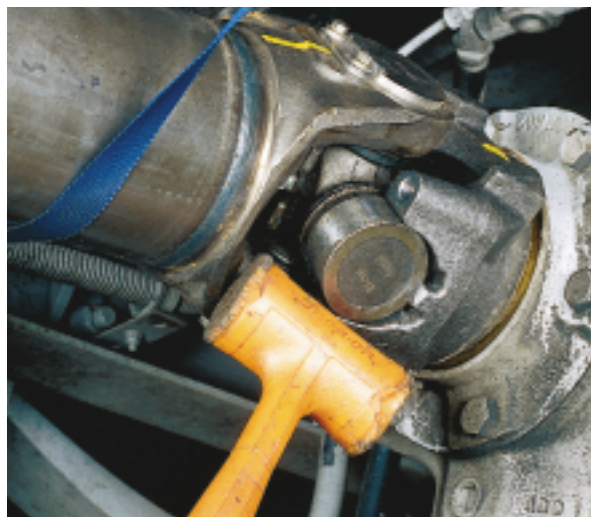
Photo 17

6. It may be necessary to unseat bearing cup assemblies by tapping on yoke or bearing cup with a soft-faced hammer. (See photo 17, above.) Once the bearing cup assemblies are free, allow the driveshaft to rest on support strap.

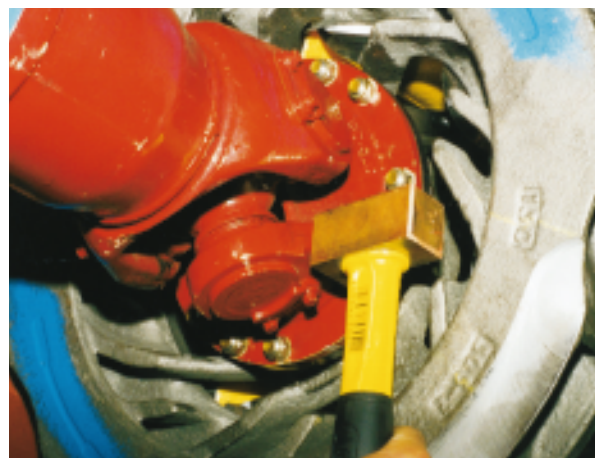
Photo 20

1. Utilizing a brass hammer and wearing safety glasses, sharply strike yoke on inboard and outboard lug ears **once**, to firmly seat bearings against spring tabs and relieve tension across span. ▲ See warning, below. Rotate shaft 180 degrees and repeat procedure on opposite inboard and outboard lug ears. (See photos 19 & 20, below.)

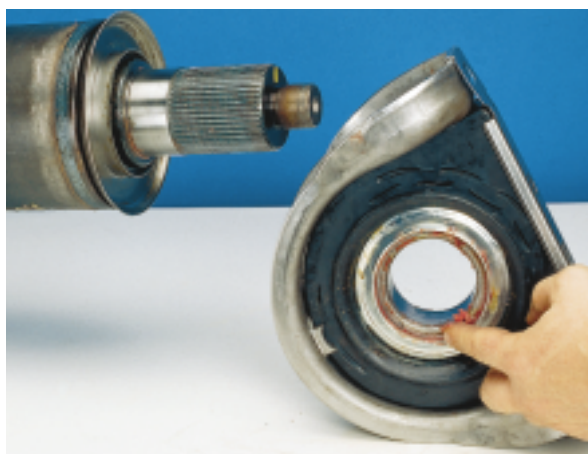
Photo 23

However, when replacing a center bearing assembly, it is necessary to fill the entire cavity around the bearing with waterproof grease to shield the bearing from water and contaminants. The quantity of lubricant should be sufficient to fill the cavity to the extreme edge of the slinger surrounding the bearing. (See photo 23, below.)

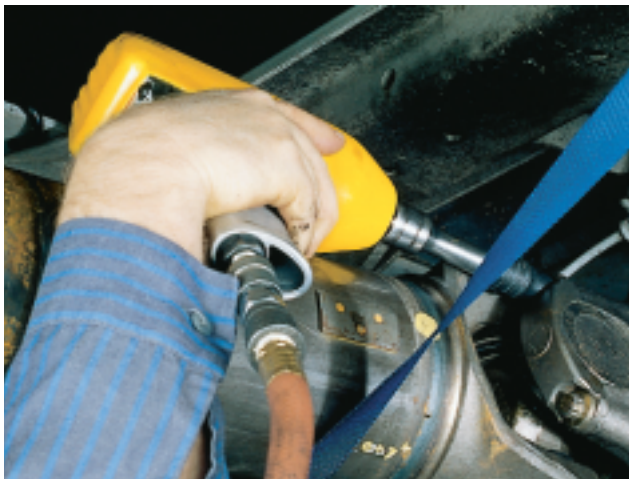
Photo 26

3. Be sure first support strap is in place as illustrated in figure C, page 41. Remove the bearing retainers or stamped straps and bolts at rear end. Discard bolts. Discard stamped straps (if applicable). (See photo 26, above.) Reference bolt specifications, Table P, below.

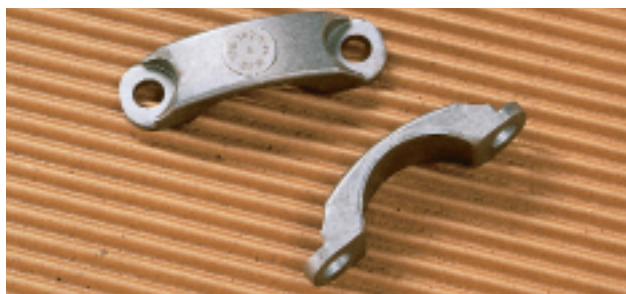
Photo 27, Bearing Retainers

Bearing retainers **CAN** be reused if there is no damage. (See photo 27, below.) If damaged, replace.

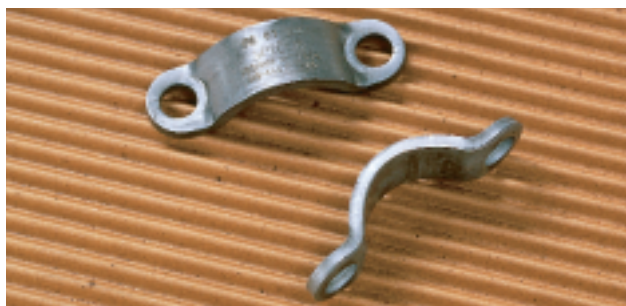
Photo 28, Stamped Straps

Stamped straps **CANNOT** be reused. (See photo 28, below.) ▲ See warning, below.

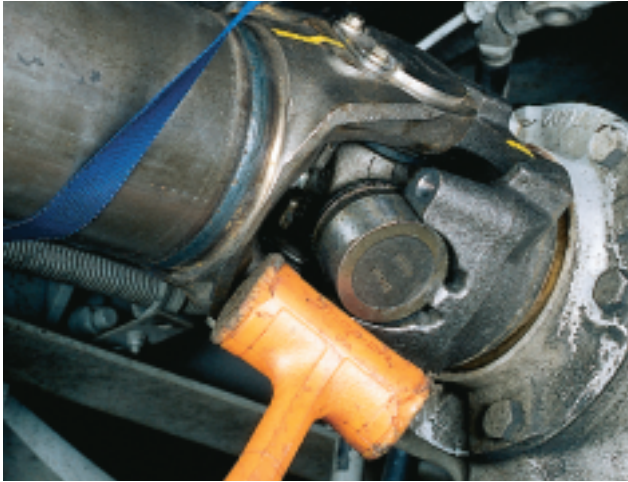
Photo 29

4. It may be necessary to unseat bearing cup assemblies by tapping on yoke or bearing cup with a soft-faced hammer. (See photo 29, above.) Once the bearing cup assemblies are free, collapse the driveshaft until both bearing assemblies clear the open end yoke cross holes. Allow the driveshaft to rest on support strap.

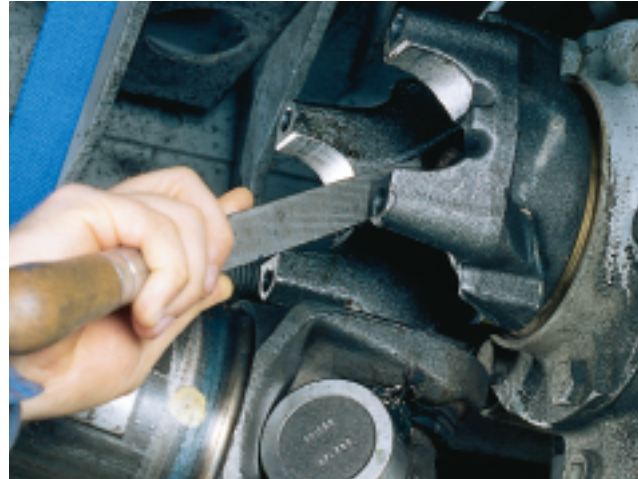
Photo 30

Raised metal or fretting on open yoke cross holes can be removed with a fine-toothed file and/or emery cloth. (See photo 30, above.) ▲ See warning, below.

DO NOT deform yoke cross holes by removing excessive metal. Raised metal or deformed yoke cross holes can be a cause of cross and bearing failure, which can result in separation of driveline from vehicle. A separated driveline can result in property damage, serious personal injury or death.

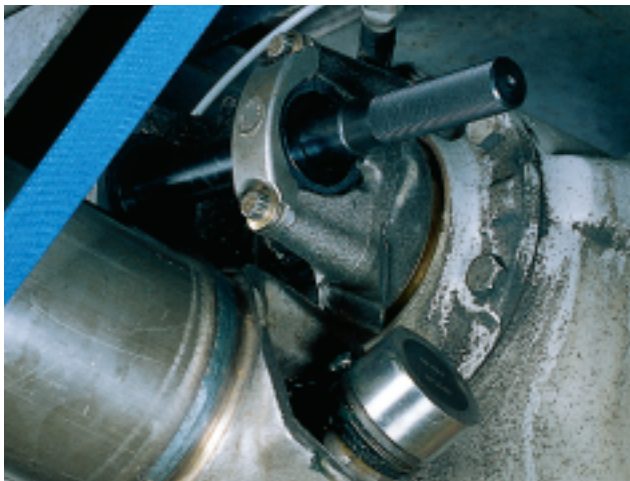
Photo 31

10. Inspect the end yoke cross holes for distortion using the appropriate Spicer alignment bar. (See photo 31, above.) Slide alignment bar through both cross holes simultaneously. If alignment bar will not pass through both cross holes simultaneously, cross holes are distorted and end yoke must be replaced. ▲ See warning, below.

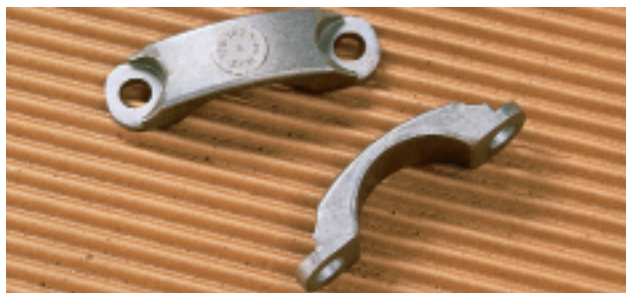
Photo 33, Bearing Retainers

Bearing retainers **CAN** be reused if there is no damage. (See photo 33, below.) If damaged, replace.

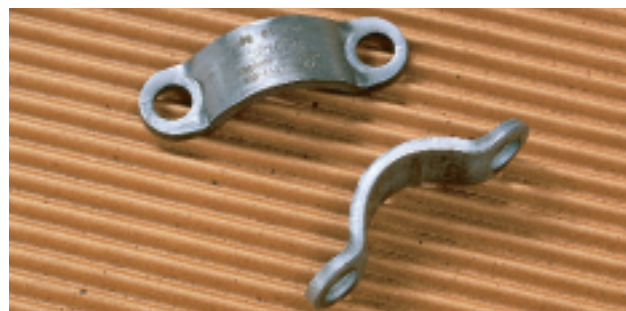
Photo 34, Stamped Straps

Stamped straps **CANNOT** be reused. (See photo 34, below.) ▲ See warning, below.

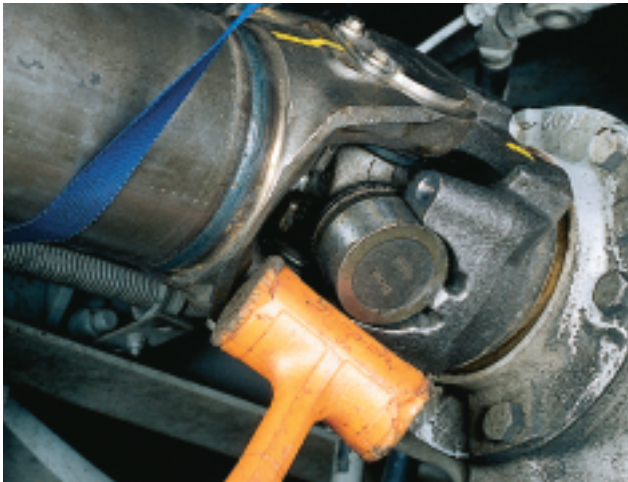
Photo 35

4. It may be necessary to unseat bearing cup assemblies by tapping on yoke or bearing cup with a soft-faced hammer. (See photo 35, above.) Once the bearing cup assemblies are free, collapse the driveshaft until both bearing assemblies clear the open end yoke cross holes. Allow the driveshaft to rest on support strap.

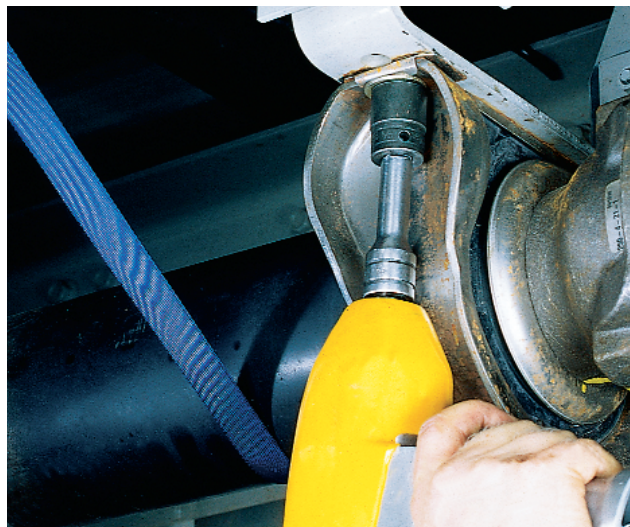
Photo 36

7. **Be sure the third support strap is in place, as illustrated in Figure D, page 46.** Remove the center bearing bracket bolts and allow the shaft to rest on the support strap. (See photo 36, below.)

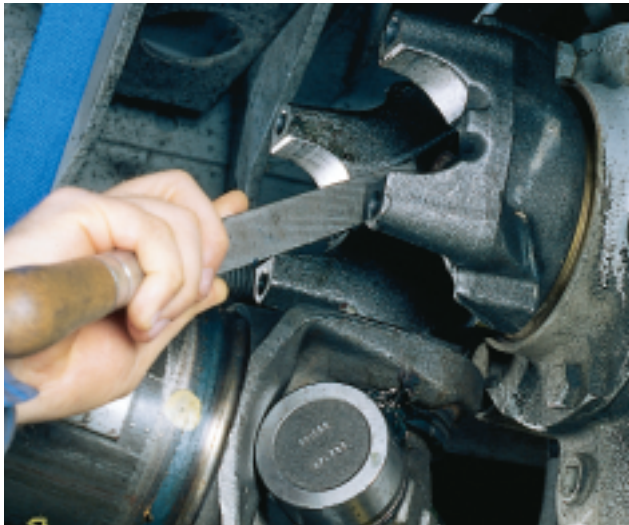
Photo 37

Raised metal or fretting on open yoke cross holes can be removed with a fine-toothed file and/or emery cloth. (See photo 37, above.) ▲ See warning, below.

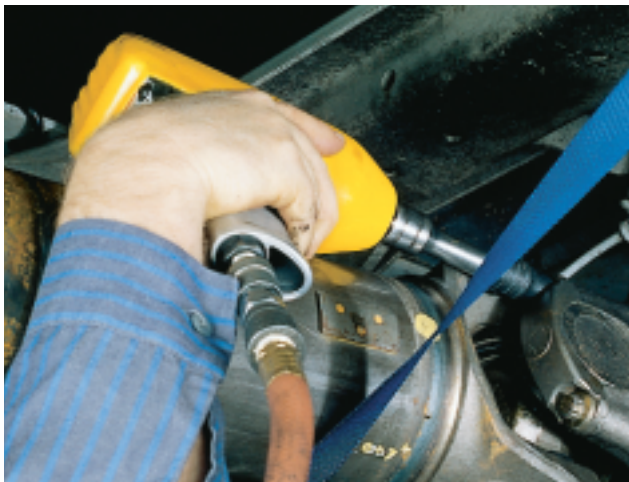
Photo 39

3. Be sure first support strap is in place as illustrated in Figure E, page 51. Remove the bearing retainers or stamped straps and bolts at rear end. Discard bolts. Discard stamped straps (if applicable). (See photo 39, above.) Reference bolt specifications, Table R, below.

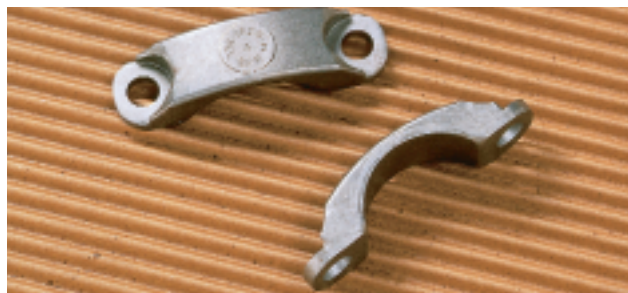
Photo 40, Bearing Retainers

Bearing retainers **CAN** be reused **if there is no damage**. (See photo 40, below.) If damaged, replace.

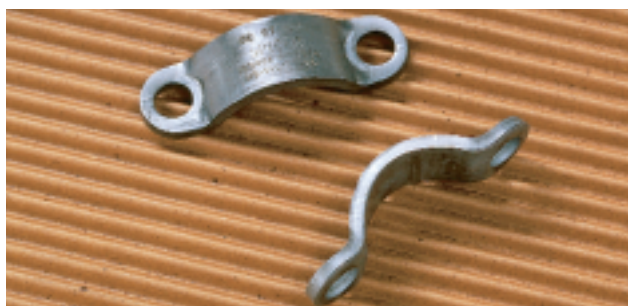
Photo 41, Stamped Straps

Stamped straps **CANNOT** be reused. Discard bolts. (See photo 41, below.) ▲ See warning, below.

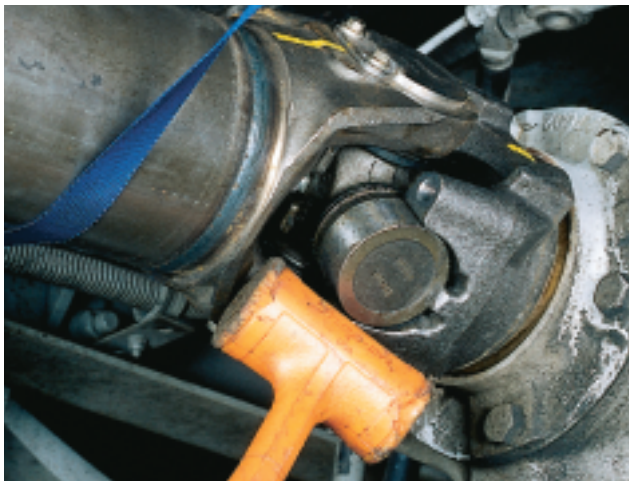
Photo 42

4. It may be necessary to unseat bearing cup assemblies by tapping on yoke or bearing cup with a soft-faced hammer. (See photo 42, above.) Once the bearing cup assemblies are free, collapse the driveshaft until both bearing assemblies clear the open yoke cross holes. Allow the driveshaft to rest on support strap.

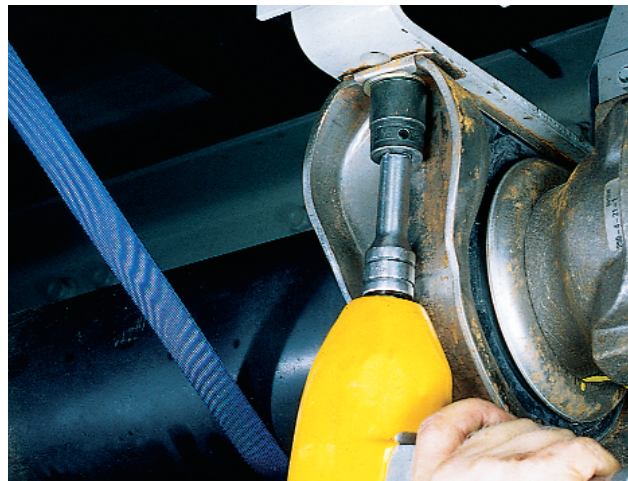
Photo 43

7. **Position third support strap as illustrated in Figure E, page 51.** Remove the center bearing bracket bolts and allow the shaft to rest on the support strap. (See photo 43, above.)

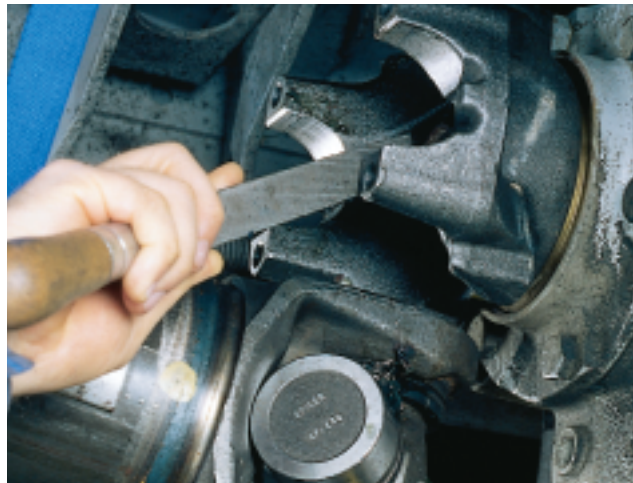
Photo 44

Raised metal or fretting on open yoke cross holes can be removed with a fine-toothed file and/or emery cloth. (See photo 44, below.) ▲ See warning, below.

***DO NOT** deform yoke cross holes by removing excessive metal. Raised metal or deformed yoke cross holes can be a cause of cross and bearing failure, which can result in separation of driveline from vehicle. A separated driveline can result in property damage, serious personal injury or death.*

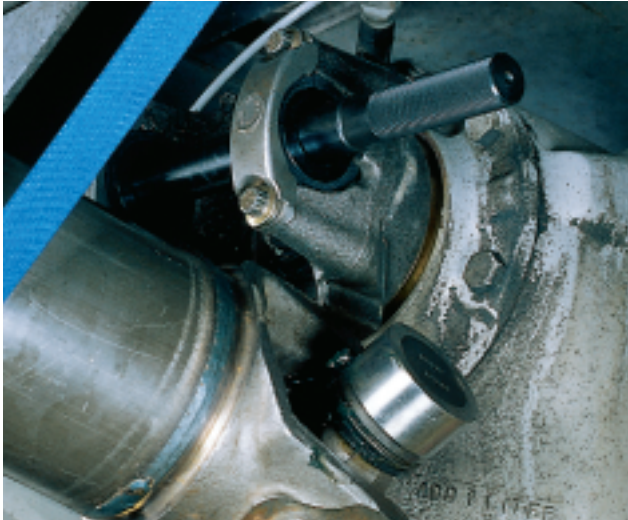
Photo 45

16. Inspect the end yoke cross holes for distortion using the appropriate Spicer alignment bar. (See photo 45, above.) Slide alignment bar through both cross holes simultaneously. If alignment bar will not pass through both cross holes simultaneously, cross holes are distorted and yoke must be replaced. ▲ See warning, below.

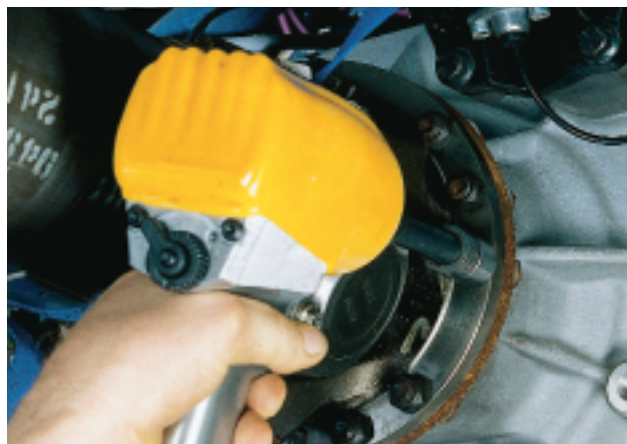
Photo 46

3. **Be sure first support strap is in place as illustrated in Figure F or G, page 57.** Remove and discard flange bolts, washers and nuts at **rear** end. Reference hardware specifications, Table S, above. (See photo 46, below.)

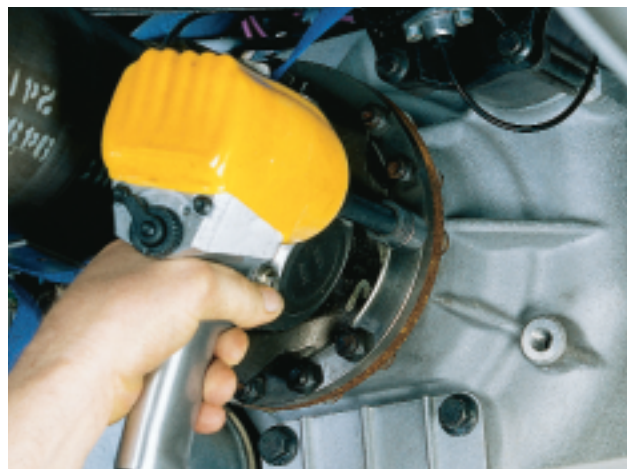
Photo 47

3. Be sure first support strap is in place as illustrated in Figures H or J, page 61. Remove and discard flange bolts, washers and nuts at front end. (See photo 47, right.)

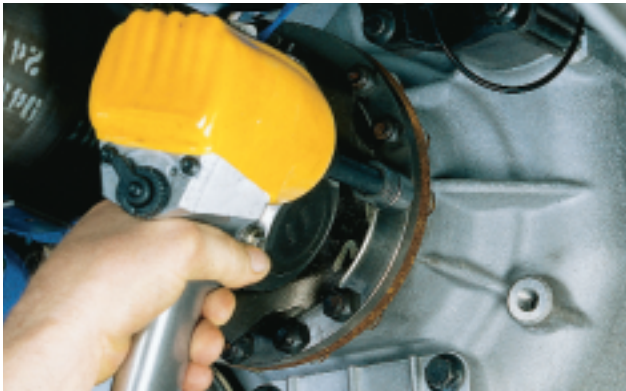
Photo 48

3. Be sure the first support strap is in place as illustrated in Figure K or L, page 65. Remove and discard flange bolts, washers and nuts at rear end. (See photo 48, page 67.) Reference hardware specifications, Table U, above.

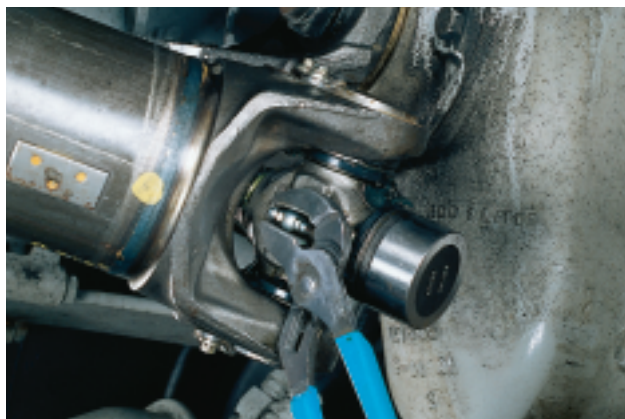
Photo 49

1. Tilt the universal joint kit or flange yoke and universal joint kit to allow access to effected grease zerk (nipple) fitting or plug. Using pliers or an open-ended wrench, turn grease zerk (nipple) fitting or plug counter-clockwise, until it is removed from the journal cross. (See photo 49, below.) Discard the grease zerk (nipple) fitting or plug.

3. Install new grease zerk (nipple) fitting (Spicer part number 232830) or plug. Tighten to minimum 15 ft. lbs. (20 Nm). Then continue to turn only until grease zerk (nipple) fitting is correctly positioned. (See photo 49 for correct grease zerk (nipple) fitting position.) ▲ See warning, below.

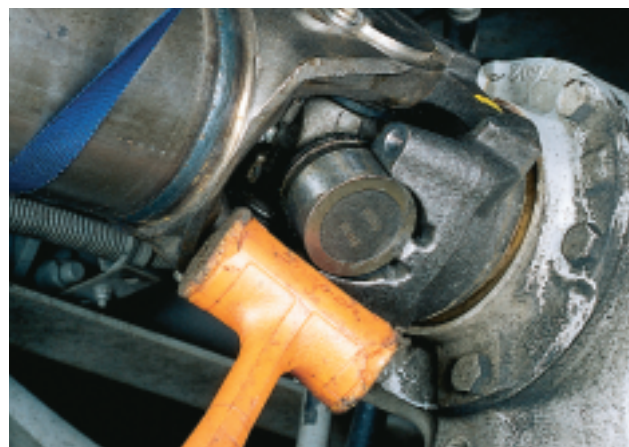
Photo 55

4. It may be necessary to unseat bearing cup assemblies, pilot or serrated connection by tapping on tube yoke or bearing cup with a soft-faced hammer. (See photo 55, below.) Once the bearing cup assemblies or connections are free, collapse the driveshaft until both bearing cup assemblies clear the open cross holes or flange yoke pilot is disconnected. Allow the driveshaft to rest on support strap.

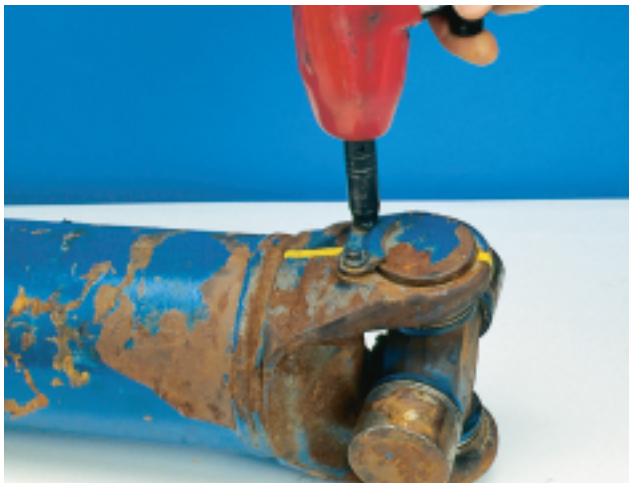
Photo 56, Quick Disconnect Style

15. Remove and discard spring tabs and bolts. Reference bolt specifications, Table X, right. (See photos 56 or 57, above). **▲** See warning, below.

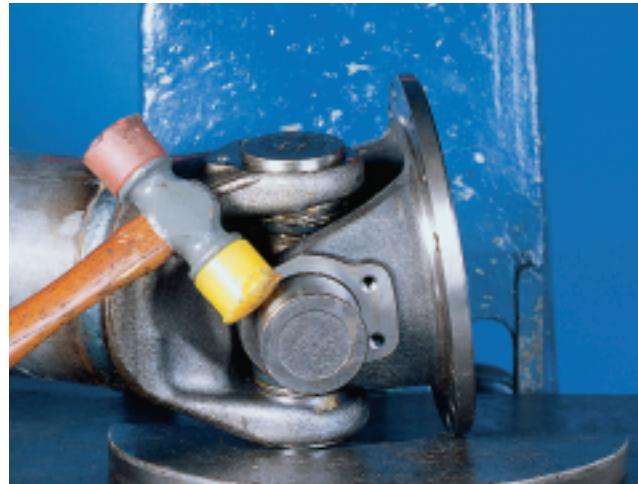
Photo 59, Companion Flange Style

17. Bearing cup is not designed to drop out of flange yoke. It will be necessary to use a soft-faced hammer to tap the partially pressed-out bearing cup from side to side, to “walk” the bearing cup out of flange yoke ear. (See photo 59, top right.)

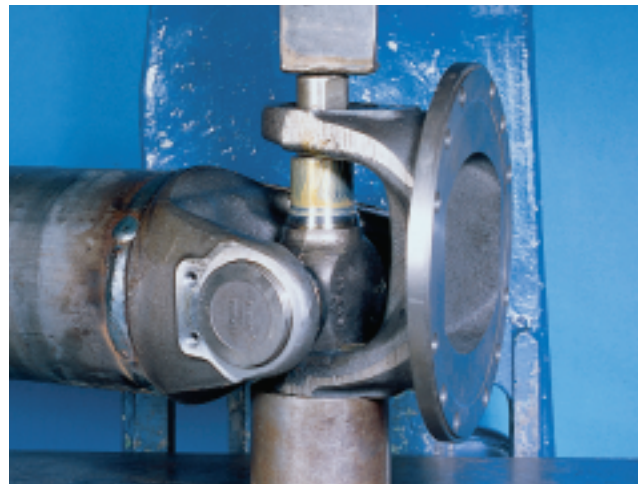
Photo 60

18. Place flange yoke in arbor press with remaining bearing cup face down. Using a push rod, press on end of the journal cross trunnion until the shoulder of the journal cross makes contact with the inside of flange yoke ear. (See photo 60, below.) Repeat step 17.

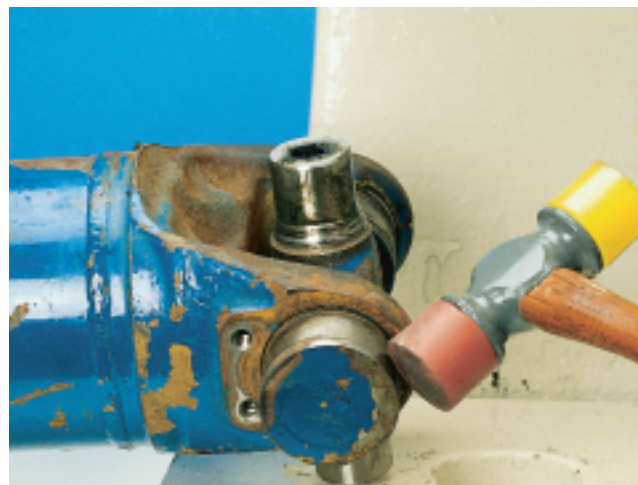
Photo 64

22. The bearing cup is not designed to drop out of the yoke. It will be necessary to use a soft-faced hammer to tap the partially pressed-out bearing cup from side to side, to “walk” the bearing cup out of the yoke ear. (See photo 64, below.)

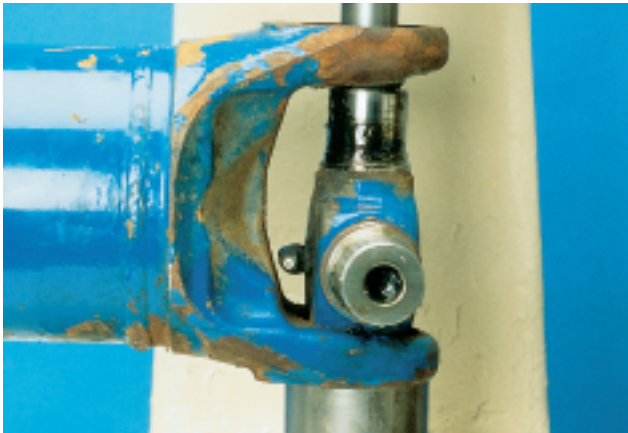
Photo 65

23. Place the yoke in the press, with the remaining bearing cup face down. (See photo 65, above.) Using a push rod, press on end of the journal cross trunnion. Continue to press down on the journal cross trunnion until the shoulder of the journal cross makes contact with the inside of the yoke ear.

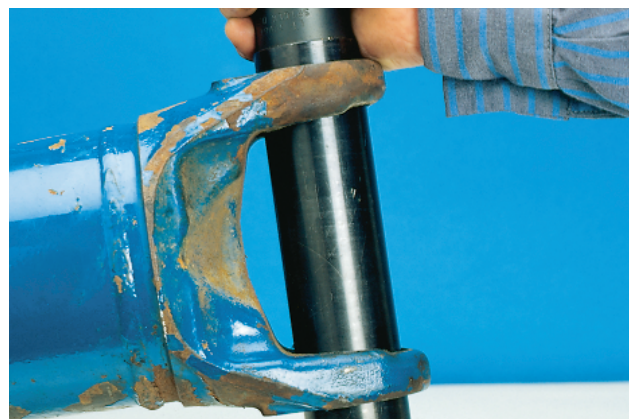
Photo 67

27. Inspect the tube yoke or flange yoke (if applicable) for distorted cross holes using an appropriate Spicer alignment bar. Slide alignment bar through both cross holes simultaneously. If alignment bar will not pass through both cross holes simultaneously, the cross holes are distorted and the shaft assembly must be replaced. (See photo 67, below.)

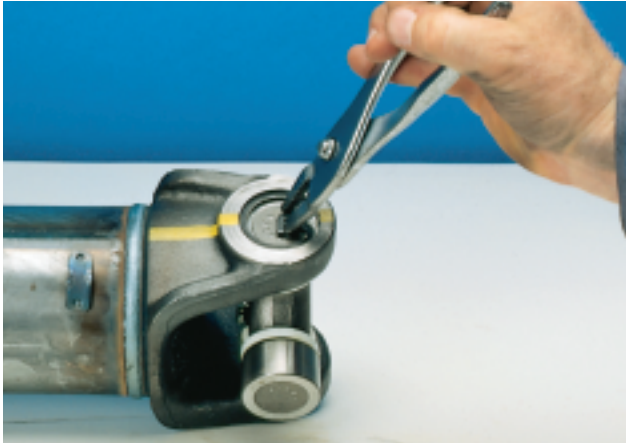
Photo 70

15. Using snap-ring pliers, remove all snap rings. (See photo 70, above.) If snap rings are severely corroded or out-of-round, snap rings must be replaced. ▲ See warning, below.

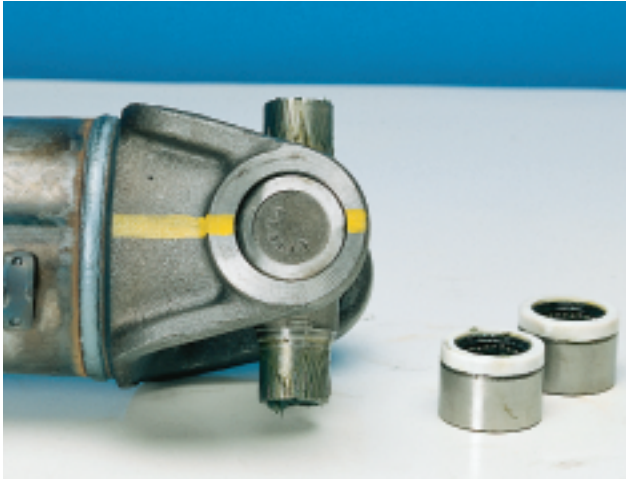
Photo 71, Correct Positioning

21. Make sure the universal joint cross assembly is not tilted in yoke. (See photos 71, top left, and 72, center left.)

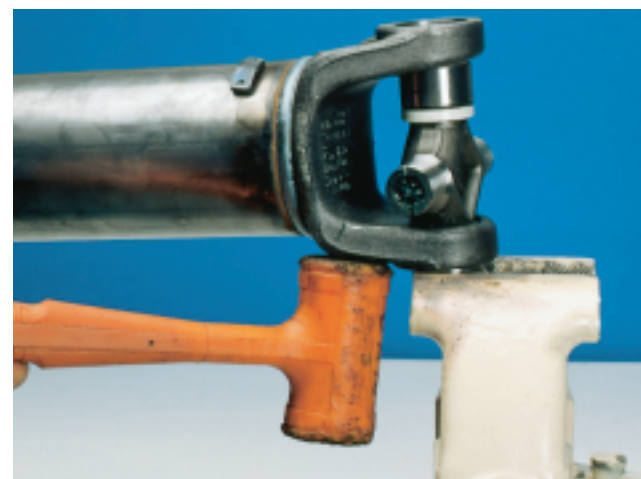
Photo 74

23. Grip the bearing cup in bench vice. (See photo 74, below.) Strike the yoke ear with a soft-faced hammer until bearing is removed.

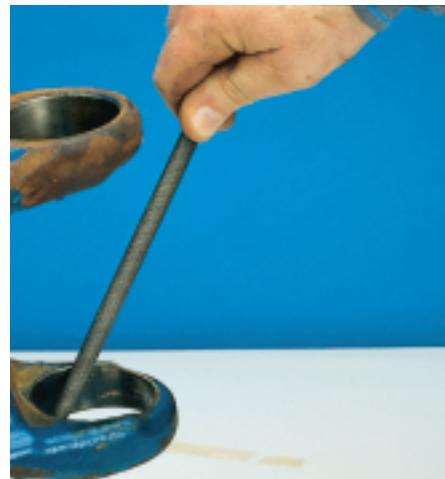
Photo 76

26. Inspect the tube yoke and flange yoke (if applicable) cross hole surfaces for damaged or raised metal. Raised metal or fretting can be removed from yoke cross holes with a fine-toothed file and/or emery cloth. (See photo 76, right.) ▲ See warning, below.

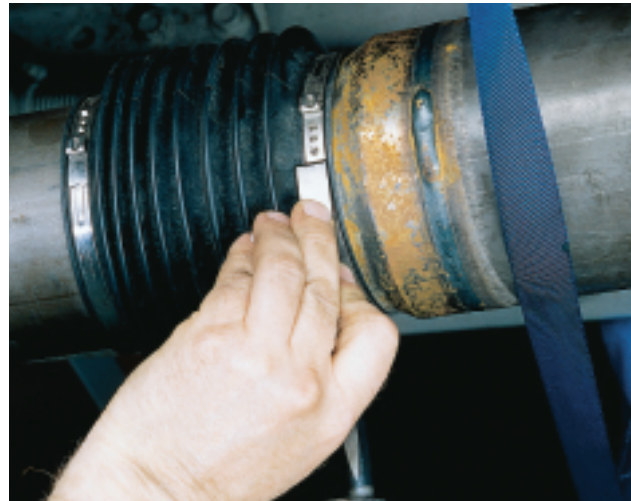
Photo 77

3. Remove and discard both boot clamps. Clamps may be separated using a chisel to disengage locking hooks. (See photo 77, above.) **DO NOT reuse clamps.** ▲ See warning, below.

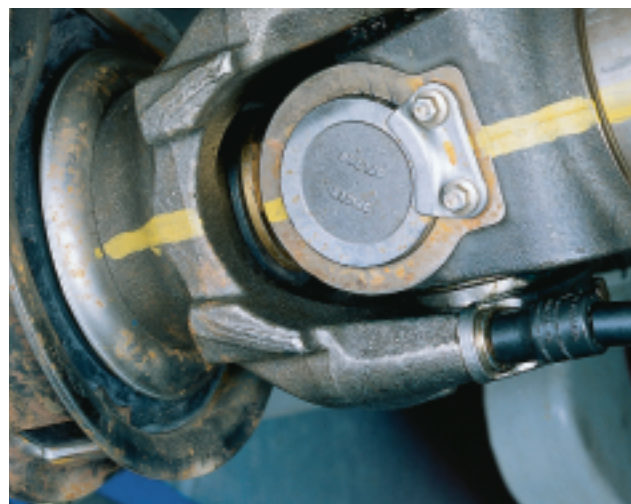
Photo 79

6. For Quick Disconnect™ style, remove bearing retainers and bolts or stamped straps and bolts at center bearing end fitting. Reference bolt specifications, Table AA, right. (See photo 79, top right.) Discard bolts.

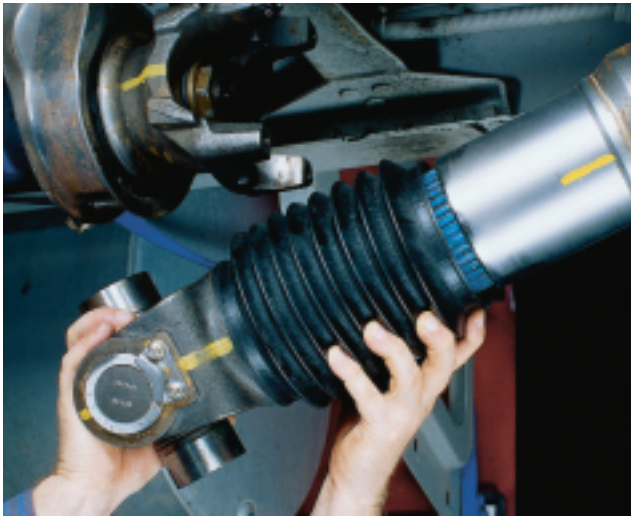
Photo 80

8. Remove the yoke shaft and boot from the spline sleeve. Discard boot. (See photo 80, above.) ▲ See warning, below.

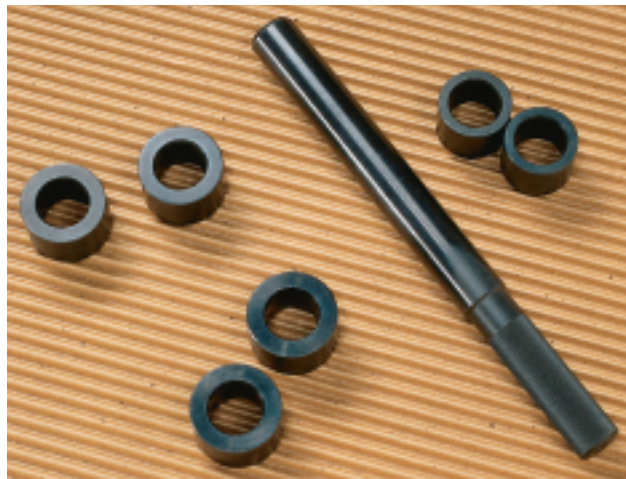
Photo 81, Spicer Alignment Bar Kit, Quick Disconnect Style

- Support Straps
- Bearing Puller
- Flange or Yoke Puller
- 6-Point Socket for Midship Nut
- 12-Point Sockets
 - English 3/8," or
 - Metric 12mm
- Spicer Alignment Bar (see photo 81 or 82, top right and right)

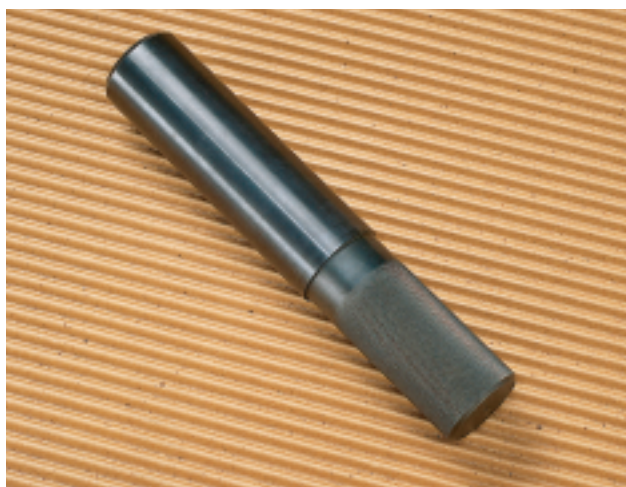
Photo 82, Spicer Alignment Bar, Companion Flange/Flange Yoke Style

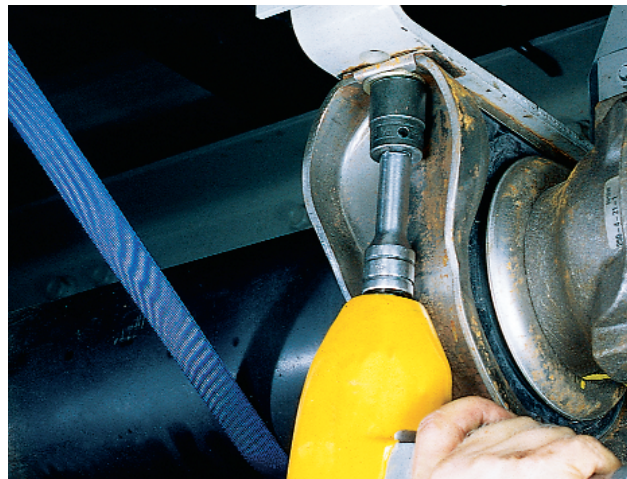
Photo 83

5. **Be sure the third support strap is in place as illustrated in Figure V, page 95.** Remove the center bearing bracket bolts and allow the shaft to rest on the support strap. (See photo 83, above.)

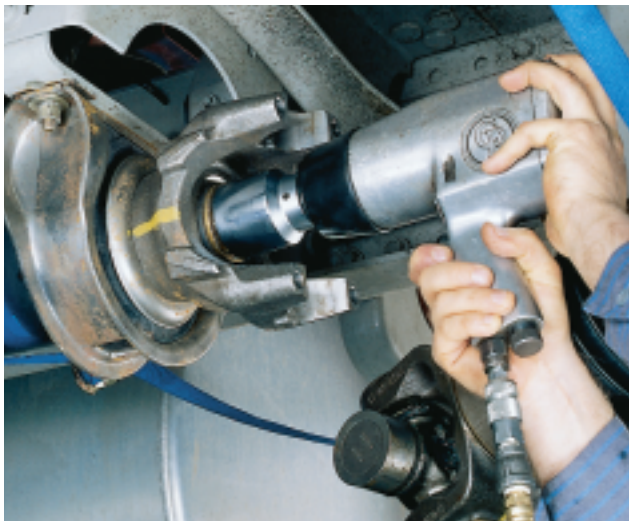
Photo 84

13. Remove midship nut. Reference midship nut specifications Table DD, above. (See photo 84, below.) Discard nut. If washer is damaged, discard and replace. Otherwise, reuse washer. ▲ See warning, below.

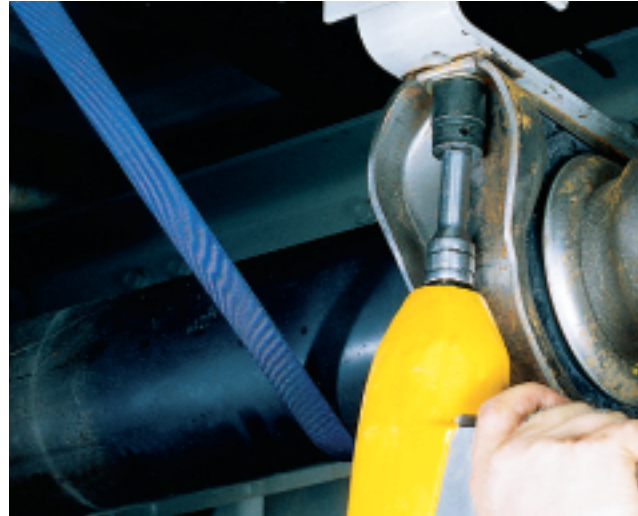
Photo 86

15. Remove center bearing bracket bolts. (See photo 86, page 99.) Allow coupling shaft to rest on support strap.

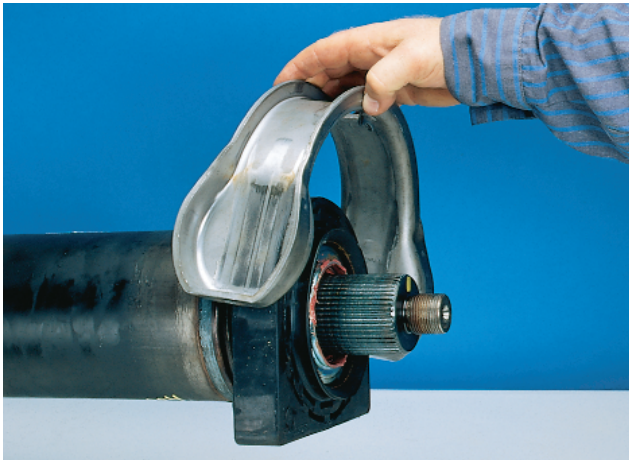
Photo 96

Remove and discard the center bearing bracket. (See photo 96, above.) Remove and discard the rubber cushion. (See photo 97, top right.)

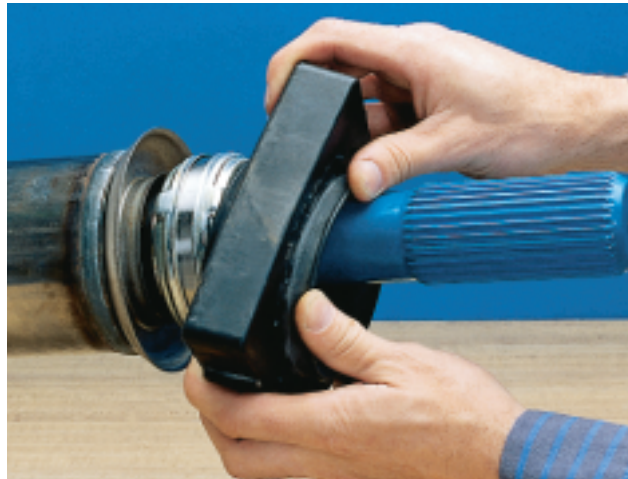
Photo 101

22. On some Spicer center bearing assemblies, a metal retainer spans the outside center bearing bracket. If present, remove metal retainer and discard. Remove and discard center bearing bracket. (See photo 100, above.) Remove and discard rubber cushion. (See photo 101, top right.)

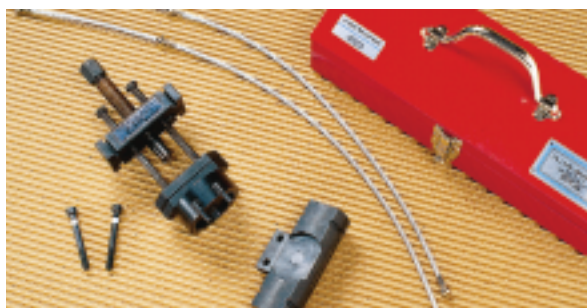
Photo 104

- J & J Tool Co., Inc. (see photo 104, right)
Universal Joint Puller Kit 4LIFE – Basic or Complete
(for Spicer Life Series 140, 170 & 250)
1-800-221-4903

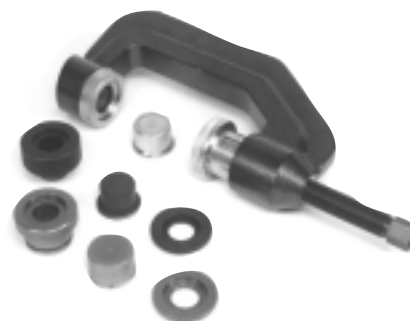
Photo 105

- Tiger Tool TGLS-597 (See photo 105, right)
or Mark 10A (not shown)
(for Spicer Life Series 140, 170 & 250)
1-800-661-4660

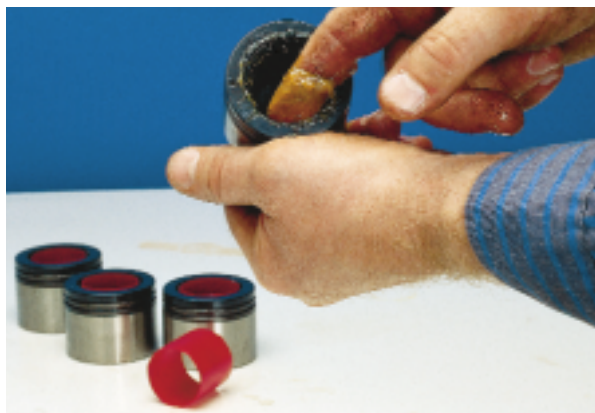
Photo 106

1. Remove needle retaining plugs from all bearing cup assemblies. Using a high-quality, N.L.G.I.*, E. P. Grade 2 lubricating grease, wipe each bearing cup assembly with grease. Fill all cavities between the needle rollers. Also apply a liberal coating of grease on the bottom of each bearing cup assembly and on the lip of the seal. (See photo 106, above.)

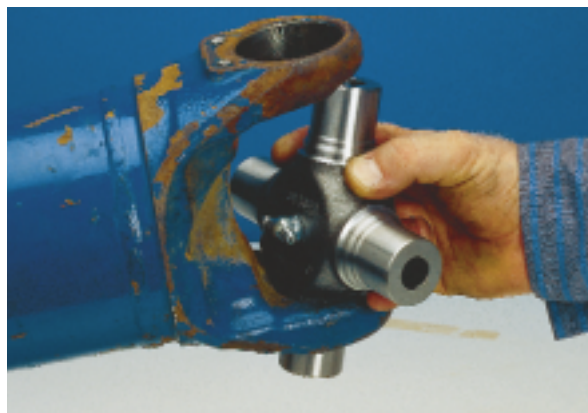
Photo 107

2. Position the journal cross into the yoke cross holes with the grease zerk (nipple) fitting inward toward tubing. The

double-headed, grease zerk (nipple) fitting should be perpendicular to the yoke cross holes. (See photo 107, above.)

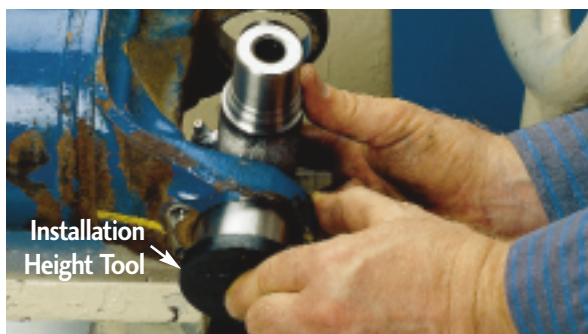
Photo 108

3. Move one end of the journal cross to cause a trunnion to project through the cross hole beyond the outer machined face of the yoke ear. Take one bearing cup assembly and position an installation height tool on the end of the bearing cup assembly. Place the bearing cup assembly over the protruding trunnion diameter and align it to the yoke cross hole. (See photo 108, below.)

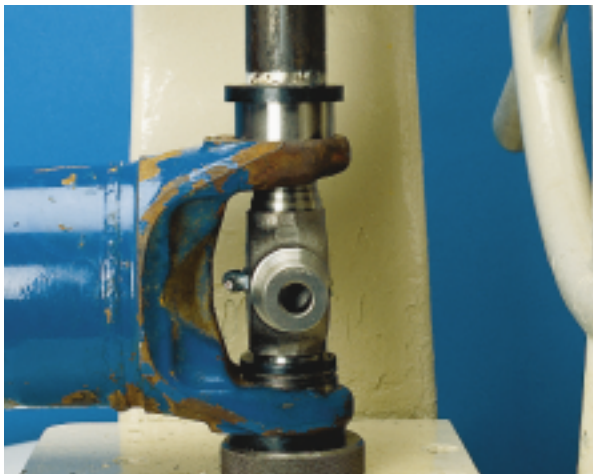
Photo 110

5. Flip yoke 180 degrees. Position the remaining installation height tool on the end of another bearing cup assembly. Place bearing cup assembly over trunnion diameter and align it to the yoke cross hole. Push the bearing cup assembly until both installation height tools are flush with the cross hole face. (See photo 110, left center.) **Remove and discard both installation height tools.**

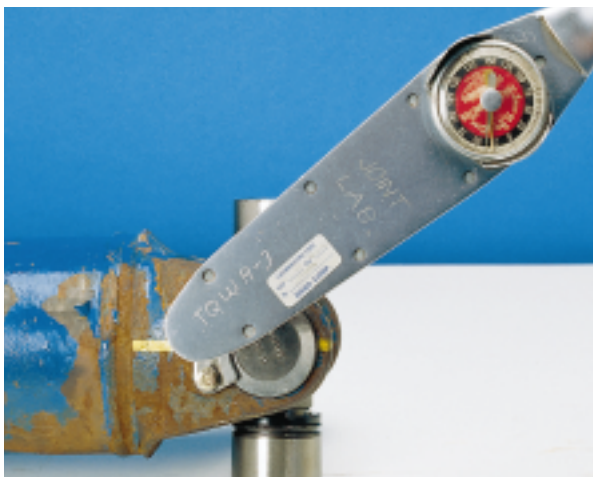
Photo 111

6. Install **new** spring tabs and 8mm thread bolts. Make sure that no grease or foreign material is present between the contact areas of the spring tabs, bearing cups and yoke cross hole faces. Tighten bolts to the required torque. (See photo 111, bottom left.) See spring tab bolt torque specification Table JJ below. ▲ See warning, below.

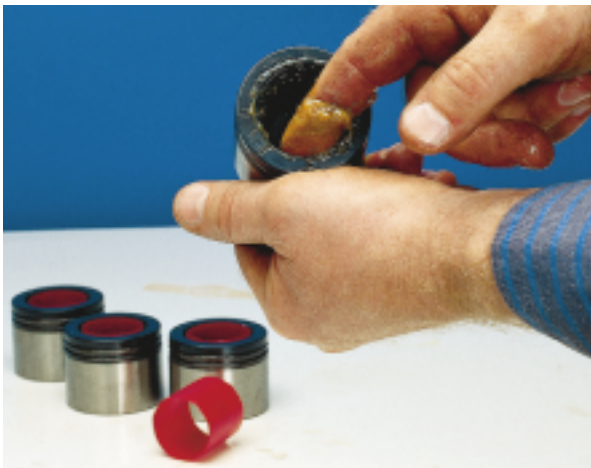
Photo 112

1. Remove needle retaining plugs from all bearing cup assemblies. Using a high-quality, N.L.G.I.* , E. P. Grade 2 lubricating grease, wipe each bearing cup assembly with grease. Fill all the cavities between the needle rollers. Also apply a liberal coating of grease on the bottom of each bearing cup assembly and on the lip of the seal. (See photo 112, below.) ▲ See warning, below.

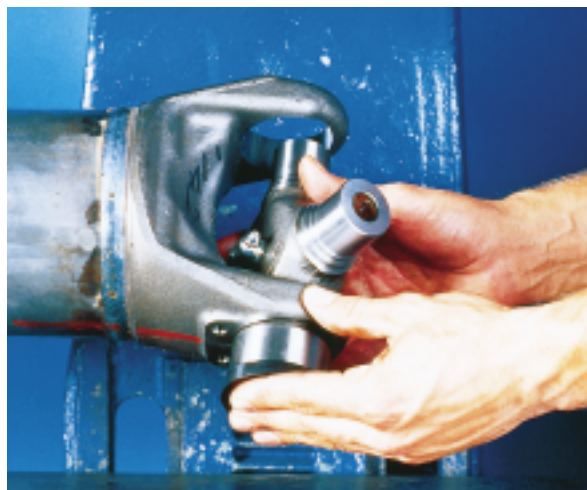
Photo 114

3. Move one end of the journal cross to cause a trunnion to project through the cross hole beyond the outer machined face of the yoke ear. Take one bearing cup assembly and position an installation height tool on the end of a bearing cup. Place the bearing cup assembly over the protruding trunnion diameter and align it to yoke cross hole. (See photo 114, top right.)

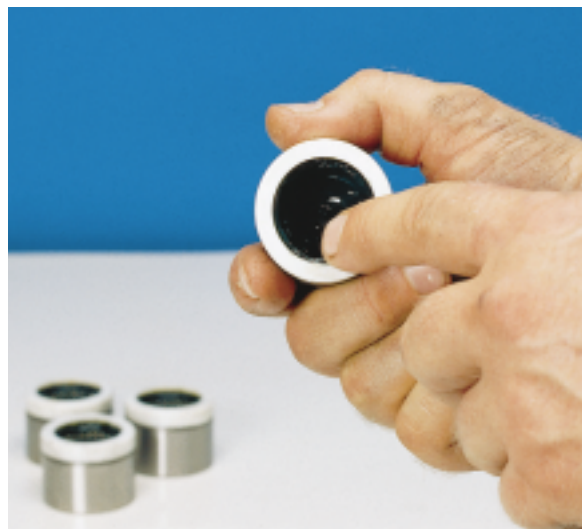
Photo 117

1. Using a high quality N.L.G.I.*, E. P. Grade 2 lubricating grease, wipe each bearing cup assembly with grease. Fill all cavities between the needle rollers. Also apply a liberal coating of grease on the bottom of each bearing cup assembly and on the lip of the seal. (See photo 117, above.)

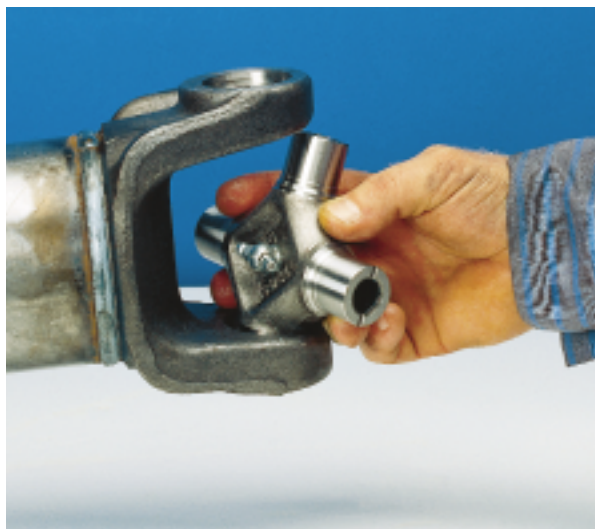
Photo 118

2. Position the journal cross into the yoke cross holes with grease zerk (nipple) fitting inward toward tubing. The double-headed, grease zerk (nipple) fitting should be perpendicular to the yoke cross holes. (See photo 118, above.)
