SPICER LIFE SERIES™ FEATURES & BENEFITS

This manual encompasses inspection, lubrication, removal and installation procedures for Spicer Life Series™ 55, 70, 90, 100, 140, 170 and 250 driveshaft assemblies.

SPICER LIFE SERIES™ INSPECTION

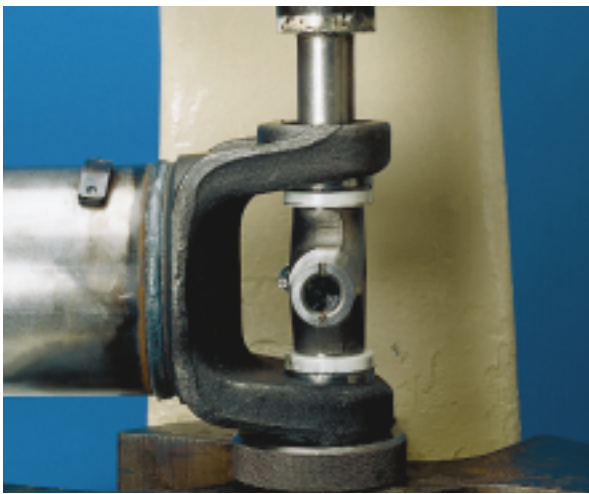
Photo 121

6. Flip yoke 180 degrees. Place another bearing cup assembly over trunnion diameter and align it to yoke cross hole. Align yoke in arbor press with previously installed bearing cup assembly resting on base of press. Place a push rod that is smaller than the bearing cup assembly on top of the bearing cup assembly. Press bearing cup assembly into the yoke cross hole until far enough to install a snap ring. (See photo 121, below.)

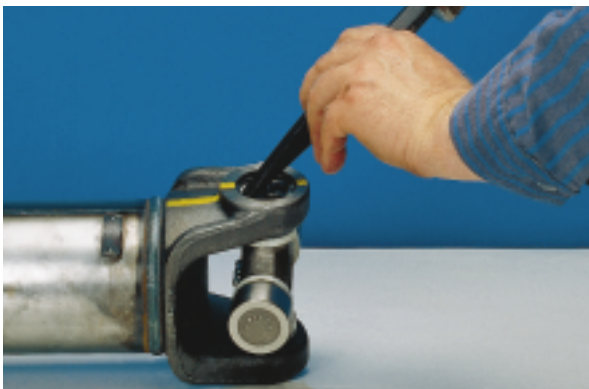
Photo 122

8. Seat installed snap rings into grooves using a small chisel or punch. (See photo 122, below.)

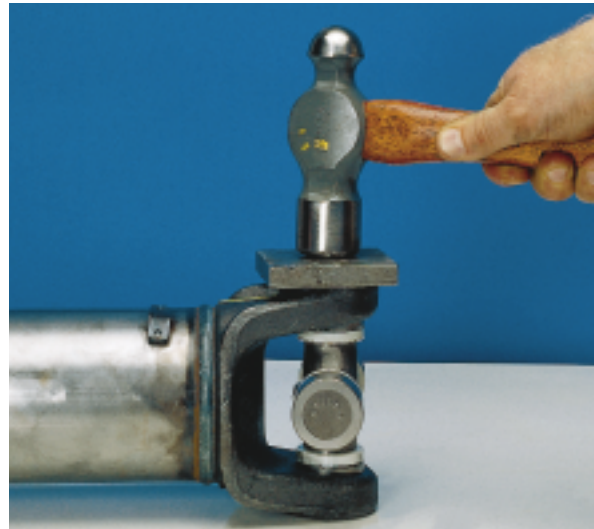
Photo 123

If the joint is stiff, place a plate on the yoke ear and hit the plate with a hammer to seat the bearing cup assemblies. (See photo 123, below.) ▲ See warning, below.

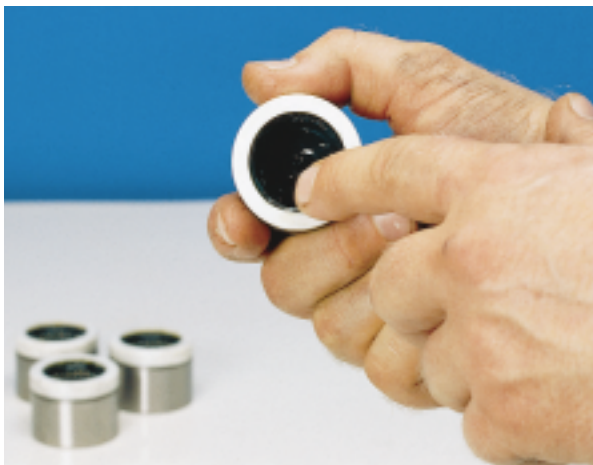
Photo 124

1. Using a high quality N.L.G.I.* Grade 2 lubricating grease, wipe each bearing cup assembly with grease. Fill all cavities between the needle rollers. Also apply a liberal coating of grease on the bottom of each bearing cup assembly and on the lip of the seal. (See photo 124, below.) ▲ See warning, below.

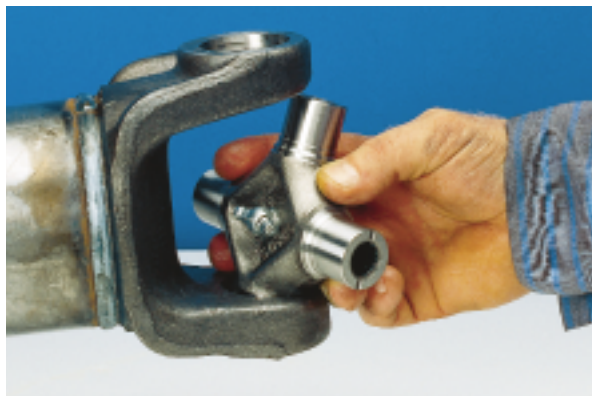
Photo 125

2. Position the journal cross into the yoke cross holes with grease zerk (nipple) fitting inward toward tubing. The double-headed, grease zerk (nipple) fitting should be perpendicular to the yoke cross holes. (See photo 125, below.)

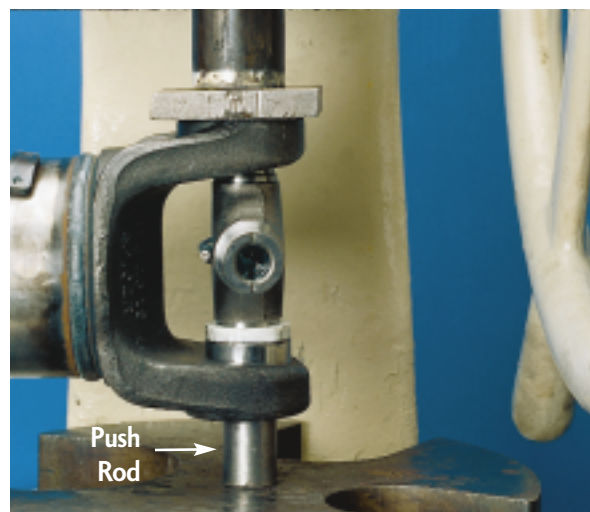
Photo 127

4. Place a push rod that is smaller than the diameter of the bearing cup assembly under the bearing cup assembly and continue pressing into the yoke cross hole until far enough to install a snap ring. (See photo 127, top right.)

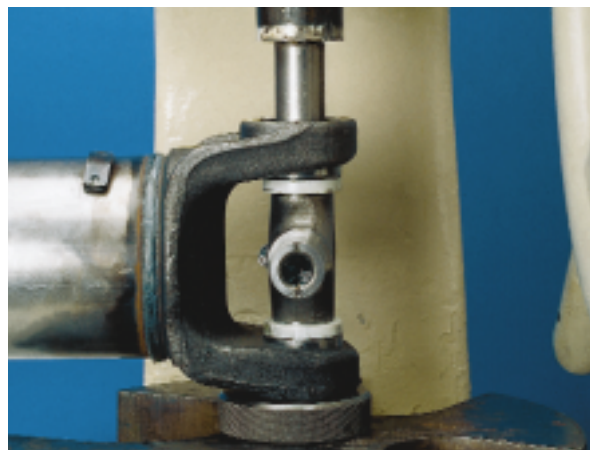
Photo 128

6. Flip yoke 180 degrees. Place another bearing cup assembly over trunnion diameter and align it to yoke cross hole. Align yoke in arbor press with previously installed bearing cup assembly resting on base of press. Place a push rod that is smaller than the bearing cup assembly on top of the bearing cup assembly. Press bearing cup assembly into the yoke cross hole until far enough to install a snap ring. (See photo 128, below.)

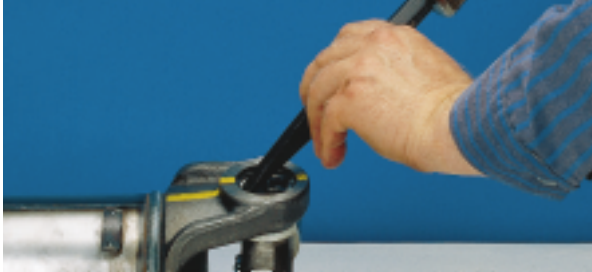
Photo 129

8. Seat the snap rings into grooves using a small chisel or punch. (See photo 129, above.)
9. Position flange yoke cross holes over remaining trunnions.

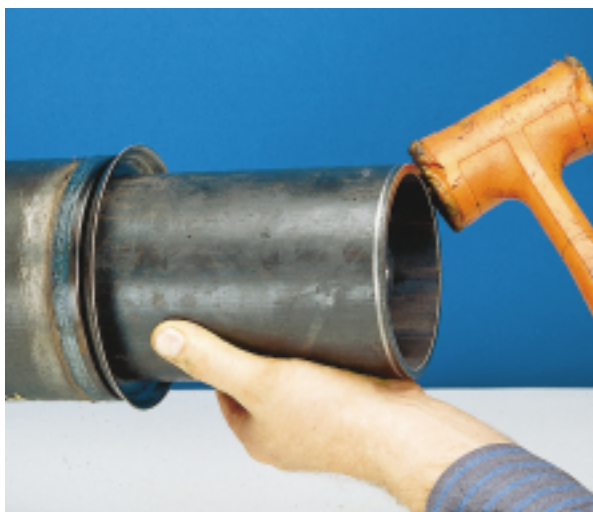
Photo 130

1. Wipe the bearing surface of the midship tube shaft with a fine emery cloth.
2. Install a new slinger (included in center bearing replacement kit) on the midship tube shaft using a section of tubing to avoid damaging slinger. Make sure the slinger is completely seated against the midship tube shaft shoulder. (See photo 130, below.)

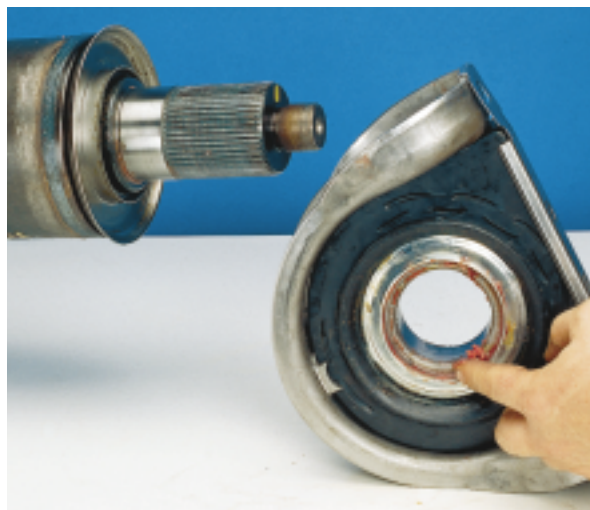
Photo 131

3. Before installing the new center bearing assembly, be sure to fill the entire cavity around the bearing with waterproof lubricant. (See photo 131, above.) Enough lubricant must be applied to fill the cavity to the extreme edge of the slinger surrounding the bearing. Lubricants **must** be waterproof. See Table LL, below for recommended lubricants. ▲ See warning, below.

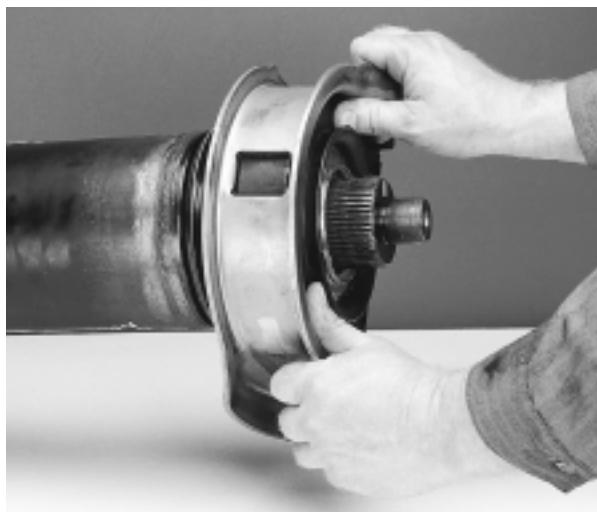
Photo 132

4. Carefully align the new center bearing assembly with the ground surface of the midship tube shaft. Physically push the center bearing onto the midship tube shaft. (See photo 132, above.)

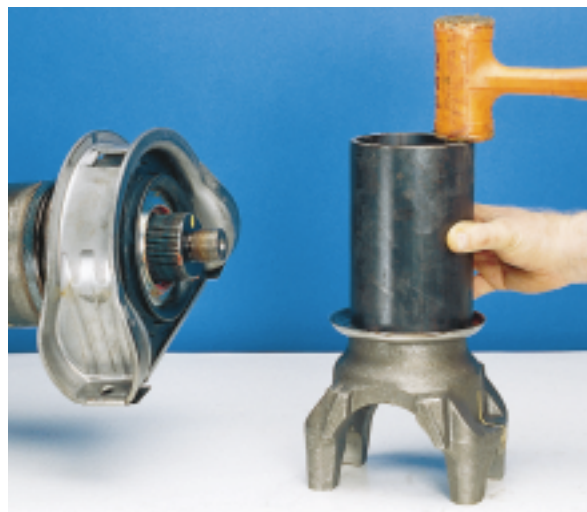
Photo 133

5. Press remaining slinger on end yoke using a section of tubing to avoid damaging slinger. (See photo 133, top right.)

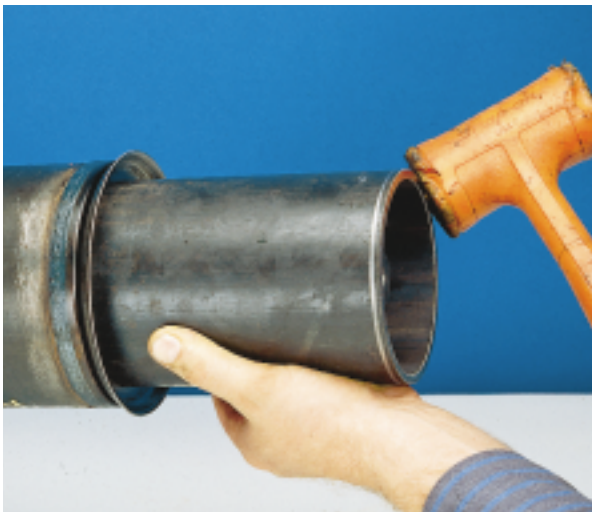
Photo 134

1. Wipe the bearing surface of the midship tube shaft with a fine emery cloth.
2. Install a new slinger (included in center bearing replacement kit) on the midship tube shaft using a section of tubing to avoid damaging slinger. Make sure the slinger is completely seated against the midship tube shaft shoulder. (See photo 134, below.)

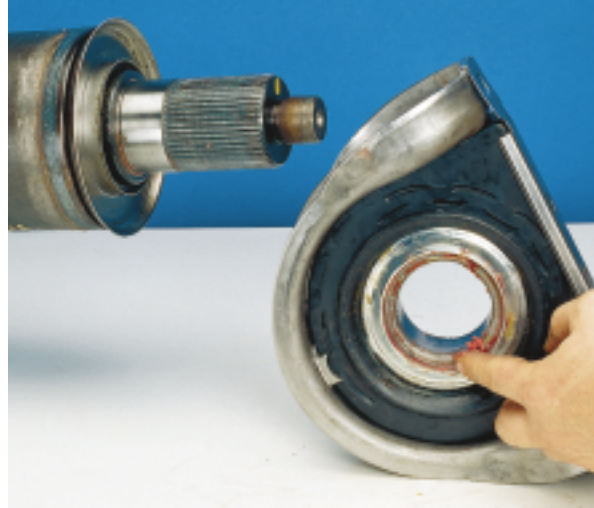
Photo 135

3. Before installing the new center bearing assembly, be sure to fill the entire cavity around the bearing with a waterproof lubricant. (See photo 135, top right.) Enough lubricant must be applied to fill the cavity to the extreme edge of the slinger surrounding the bearing. Lubricants **must** be waterproof. See Table NN, top right, for recommended lubricants. ▲ See warning, below.

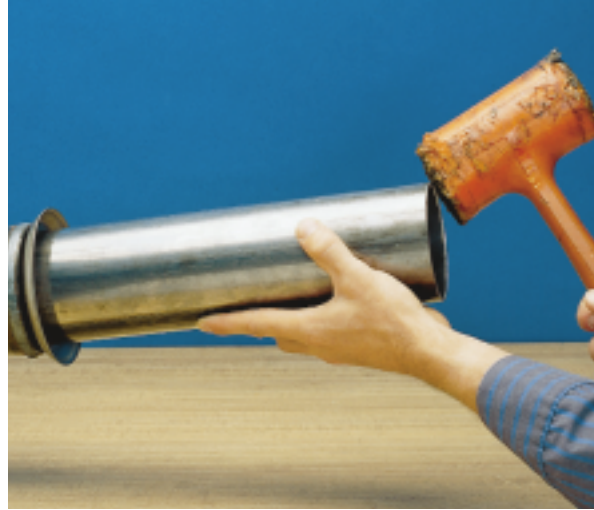
Photo 138

2. Install a new slinger (included in center bearing replacement kit) on the midship tube shaft using a section of tubing to avoid damaging slinger. Make sure the slinger is completely seated against the midship tube shaft shoulder. (See photo 138, top right.)

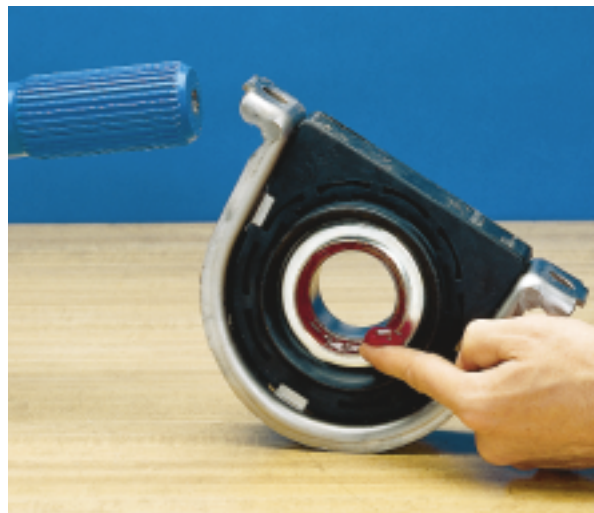
Photo 139

3. When replacing a center bearing assembly, be sure to fill the entire cavity around the bearing with a waterproof lubricant (see photo 139, center right.) Enough lubricant must be applied to fill the cavity to the extreme edge of the slinger surrounding the bearing. Lubricants **must** be waterproof. See Table QQ, bottom right for recommended lubricant.

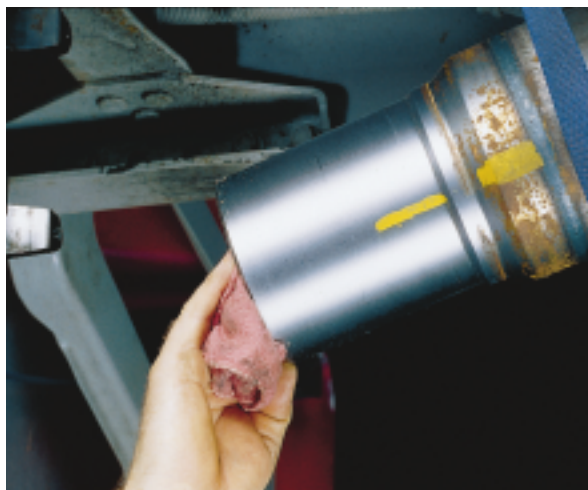
Photo 140

1. Clean **ALL** grease from yoke shaft and spline sleeve. Make sure grease-cutting solvent does not intrude into the tube through the vent hole in the spline sleeve plug. **Be sure the phasing marks made during disassembly are not removed.** (See photo 140, top right.)

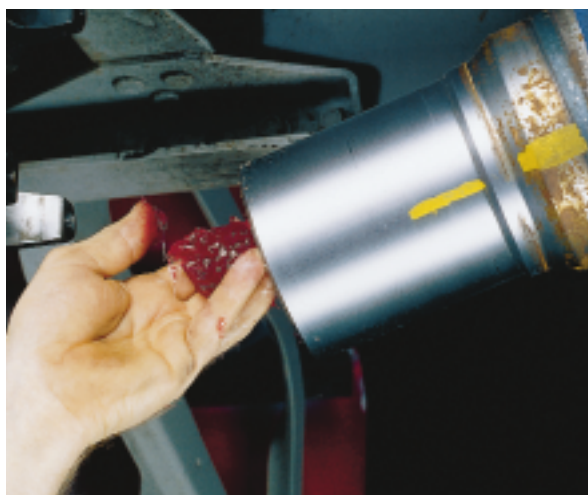
Photo 141

2. After all traces of grease-cutting solvent have been removed from yoke shaft and spline sleeve, apply enough N.L.G.*, E. P. Grade 2 grease (provided in slip member boot replacement kit) to fill the entire length of all teeth in the spline sleeve (see photo 141, right.) Wipe any excess grease on the **teeth** of the yoke shaft. **▲** See warning, below.

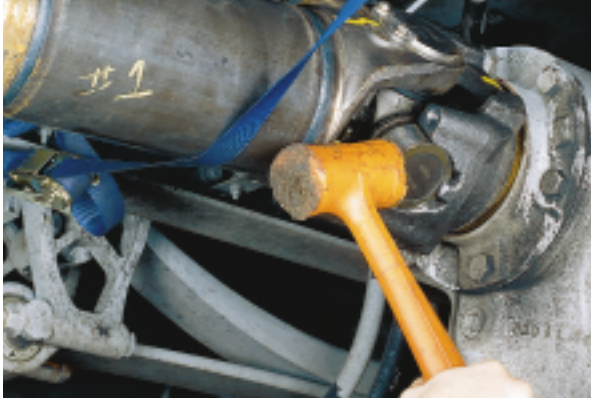
Photo 143

3. Working from the **front end**, use a soft-faced hammer to tap the universal joint into the end yoke. Make sure to align

the universal joint in end yoke, **matching up the phasing marks made during removal to ensure original driveshaft orientation.** (See photo 143, above.)

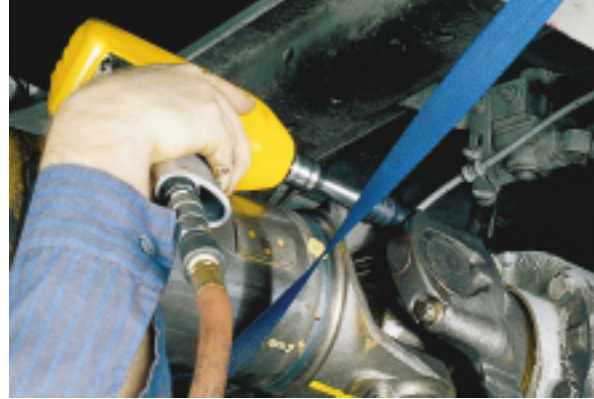
Photo 144

4. Install the bearing retainers or **new** stamped straps and **new bolts** (see photo 144, top right.) Torque the bolts down evenly and to required specifications. Check to make sure the bearing cup assemblies are fully seated in the yoke ears.

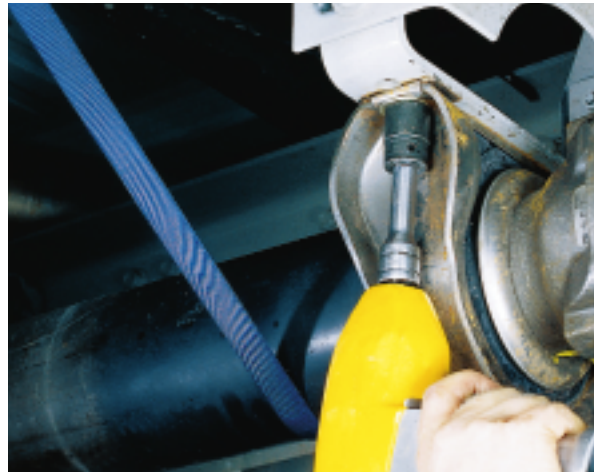
Photo 145

5. Be sure the second support strap is in place, as illustrated in Figure AA, page 138. Lift the center bearing to the center bearing bracket on the cross member of the frame. Install proper center bearing bracket bolts, per vehicle manufacturer's recommendations. (See photo 145, above.) Torque bolts to vehicle manufacturer's required specifications. ▲ See warning, below.

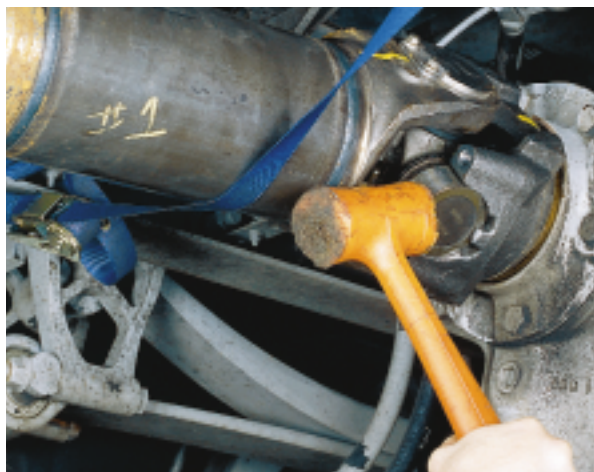
Photo 146

7. Working from the **rear end**, use a soft-faced hammer to tap the universal joint into the rear end yoke. Make sure to align the universal joint in the rear end yoke, **matching up phasing marks made during removal to ensure original driveshaft orientation**. (See photo 146, above.) ▲ See warning, below.

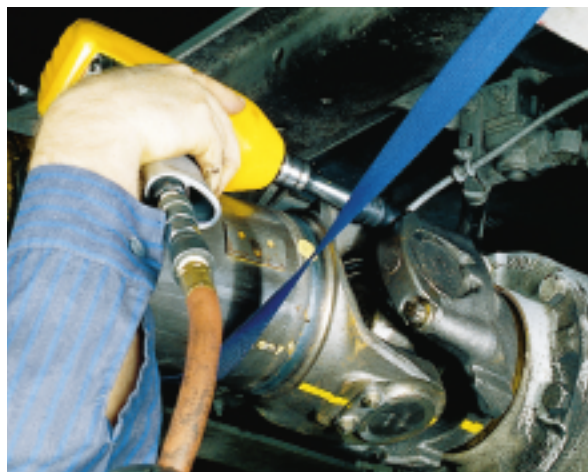
Photo 147

8. Install bearing retainers or **new** stamped straps and **new** bolts. (See photo 147, above.) Torque the bolts down evenly and to required specifications. Check to make sure the bearing cup assemblies are fully seated in yoke ears. Table WW, right. ▲ See warning, below.

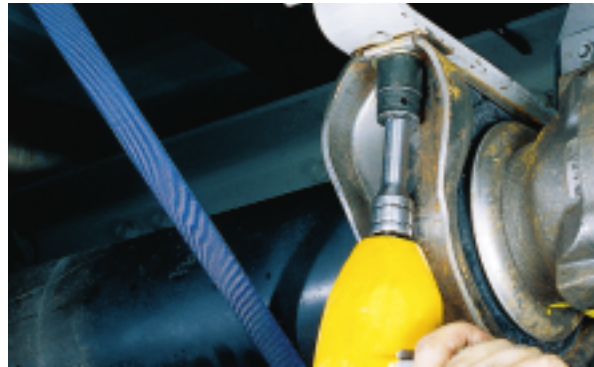
Photo 148

6. Be sure the second support strap is in place, as illustrated in Figure BB, page 142. Lift the center bearing to the center bearing bracket on the cross member of the frame. Install proper center bearing bracket bolts, per vehicle manufacturer's recommendations. (See photo 148, top right.) Torque bolts to vehicle manufacturer's required specifications. ▲ See warning, below.

10. Be sure the fourth support strap is in place, as illustrated in Figure BB, page 142. Lift the center bearing to the center bearing bracket on the cross member of the frame. Install proper center bearing bracket bolts, per vehicle manufacturer's recommendations. (See photo 148, page 143.) Torque bolts to vehicle manufacturer's required specifications. ▲ See warning, below.

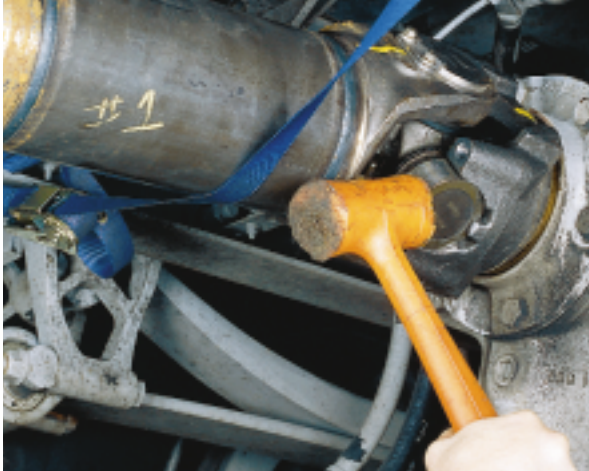
Photo 149

13. Working from the rear end, use a soft-faced hammer to tap the universal joint into the rear end yoke. Make sure to align the universal joint in the rear end yoke, **matching up phasing marks made during removal to ensure original driveshaft orientation.** (See photo 149, above.) ▲ See warning, below.

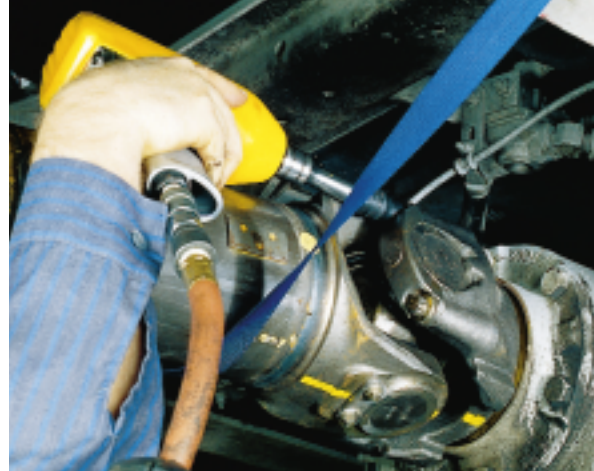
Photo 150

14. Install bearing retainers or **new** stamped straps and **new** bolts. (See photo 150, page 144). Torque the bolts down evenly and to required specifications. Check to make sure the bearing cup assemblies are fully seated in yoke ears. Table ZZ, Page 144. ▲ See warning, below.

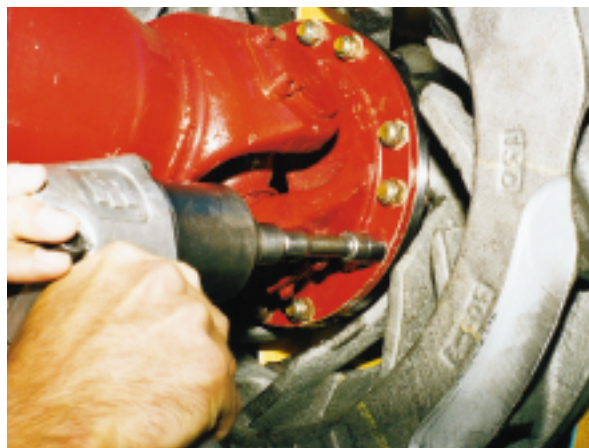
Photo 151

4. Install **new bolts**, washers (if required) and nuts. (See photo 151, above.) Reference hardware specifications, Table BBB, above. Bolts must be torqued to required specifications. ▲ See warning, below.

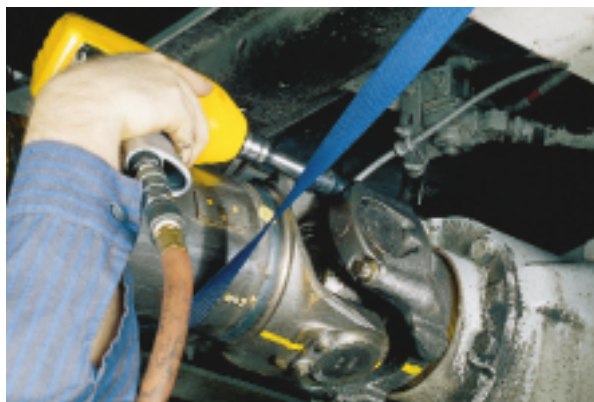
Photo 152

4. Install **new** bolts, washers (if required) and nuts. (See photo 152, page 151.) Reference hardware specifications, Table CCC, above. Bolts must be torqued to required specifications. ▲ See warning, below.

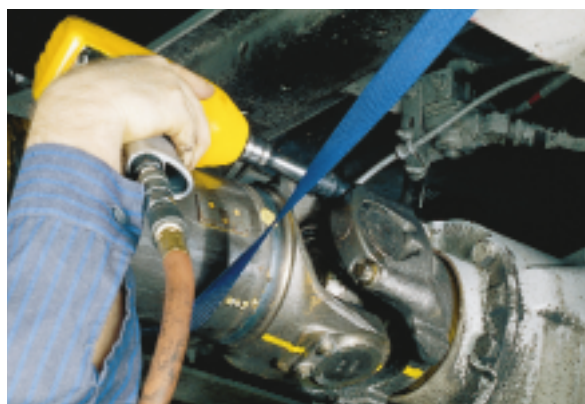
Photo 153

5. Install **new** bolts, washers (if required) and nuts. (See photo 153, above.) Reference hardware specifications, Table DDD, above. Bolts must be torqued to required specifications. ▲ See warning, below.
